Geological aspects of seepage problem and its management at Khanpur dam project, Pakistan

Mohammad Saleem Khan¹, Mian Ali Gul² and Mubashir Aziz³

Abstract

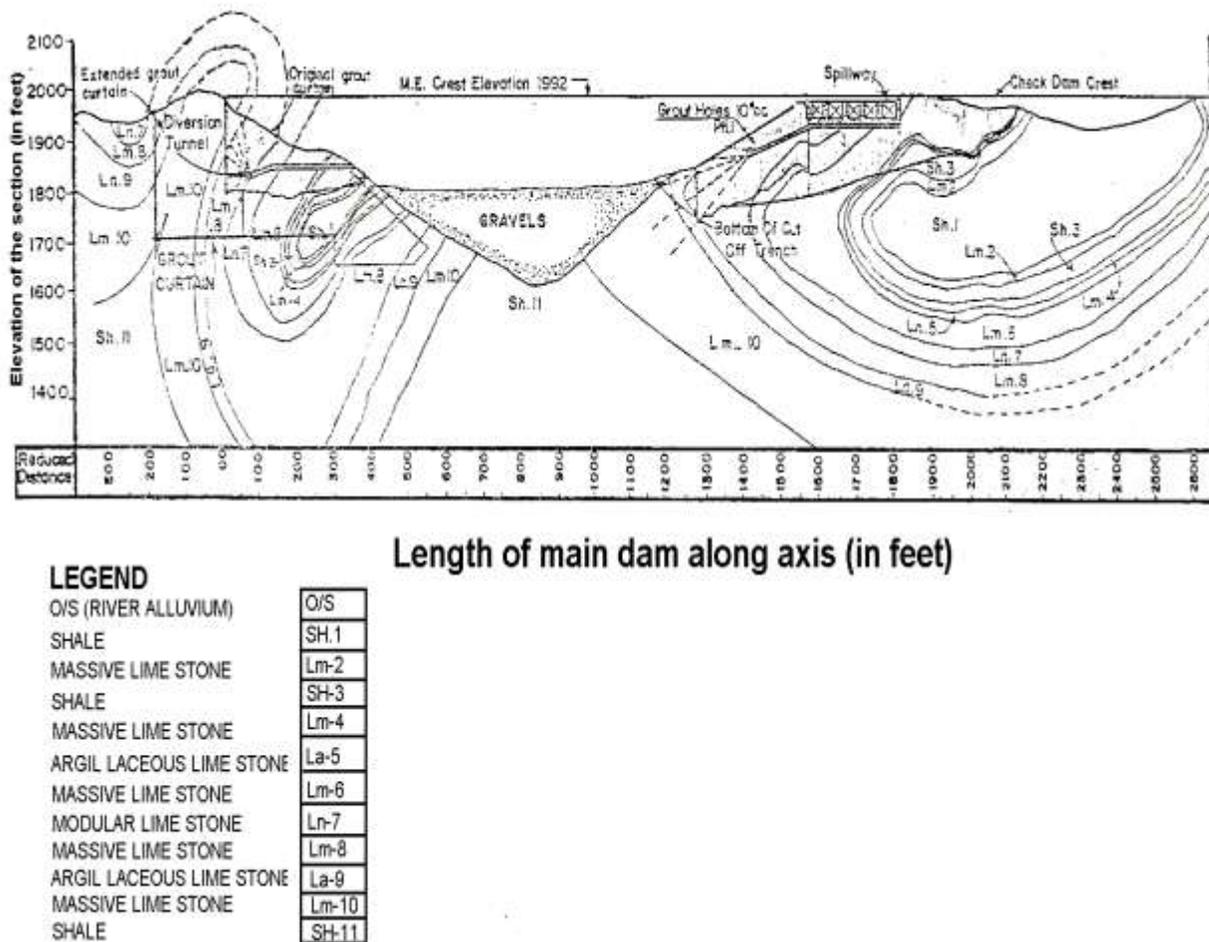
The geology of Khanpur dam site is predominantly composed of limestone formation of Margalla Hill limestone Formation of Eocene age (Shah, 1977). Associated Consulting Engineers have classified the formation into twelve rock units given in Table 1 (ACE, 1984). The river valley at dam site is filled with thick alluvial deposits. Series of anticline and syncline structures are present in the area. The river at dam site flows through eroded anticline where as right and left abutments are synclines as shown in the typical cross section along the axis of the main dam (Fig. 2). The strike of all these rock units is day lighting in the reservoir from where huge amount of water enters through contact planes and

discontinuities which seeps out downstream of the dam. An uninvestigated source of seepage is from Chohae area where a number of normal faults are responsible for huge amount of water loss through seepage.

Fig. 2. Typical cross-section along the axes of the main dam indicating the sub-surface geological and structural setup responsible for high seepage (ACE, 1984)
