Damage assessment of flood affected mud houses in Pakistan

Attaullah Shah¹, Hamid Mumtaz Khan² and Ehsan U. Qazi³

Abstract

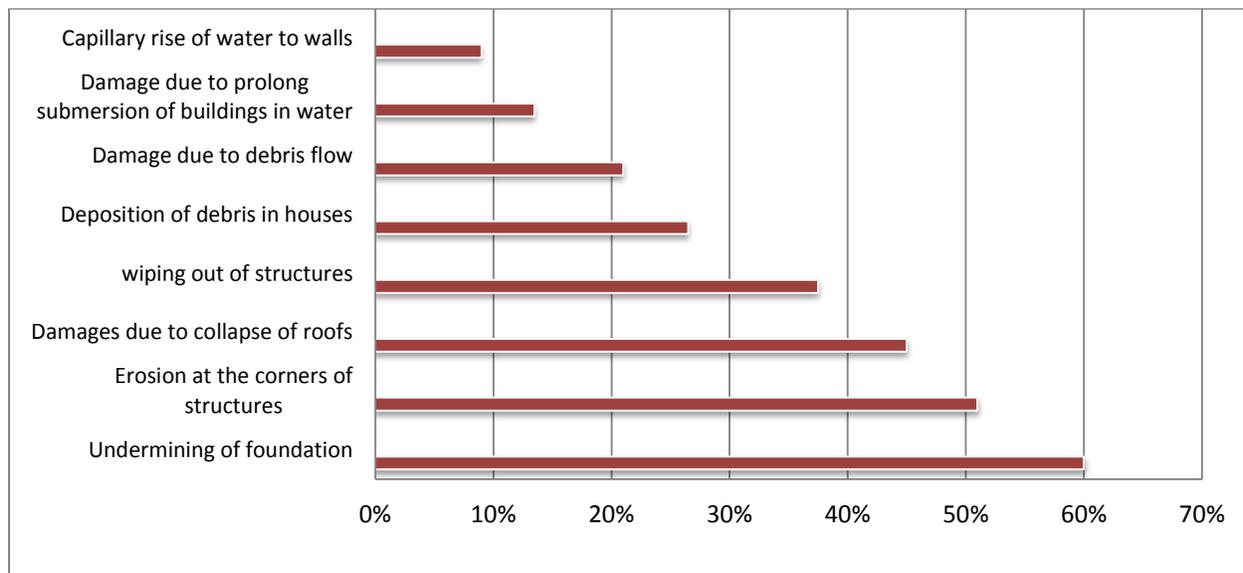
The major causes of damages of the mud houses in the flood affected areas are given in Figure 3.

Fig. 3. Major causes of collapse of the mud houses in the flood affected areas.

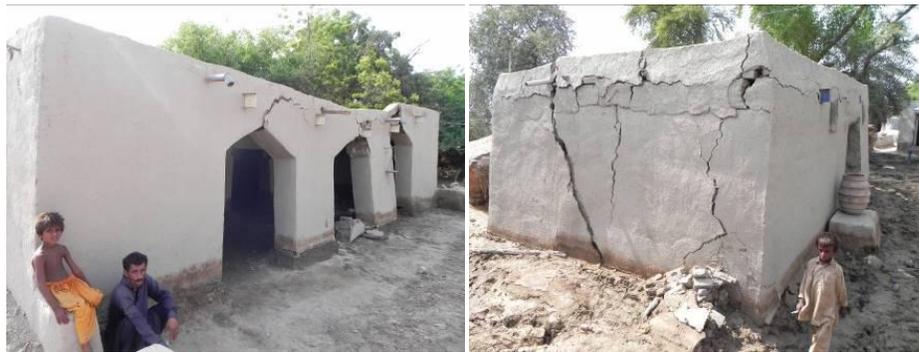
In most of the cases there was no plinth protection to prevent access of flood water to the foundations. This subsequently led to the settlement of foundation and ultimately collapse of mud houses. In Figure 4, two such houses are shown. In some cases, where raised platform was constructed around the building or building was constructed on elevated platform, the relative damages were less.

Fig. 4. The damaged houses due to undermining of the foundation by flood water.

Rising of platform and plinth above ground level will protect the mud houses from the access of water. The following improvements have been suggested (Design hand book, 2010):

- i. The platform must be raised at least 1ft above to regular flood level with compacted earth and extend the edges minimum 3ft away from building footprint.
- ii. The slope of platform may be maintained for sandy soil at 1V to 2H (For each vertical ft height, horizontal width of 2 feet) and for clayey soil; 1V:1.5H.
- iii. The water must be drained away from the building. For control of erosion of platform, deep rooted edge plants, bushes or grass may be grown on edge. Alternatively brick pitching may be provided.

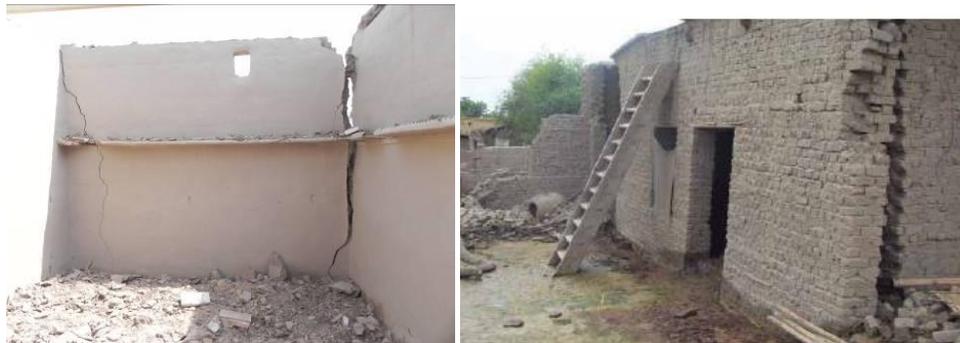
provide weak areas for the earthquake and floods, due to lack of proper bond. In floods, due to continued exposure to the walls to the torrential rains, these weak corners are further expose and the top cover of mud plaster is washed away, thereby making these corners further weaker. Some of such damages are shown in the Figure 5.

Fig. 5. Damaged houses due to splitting of corners.

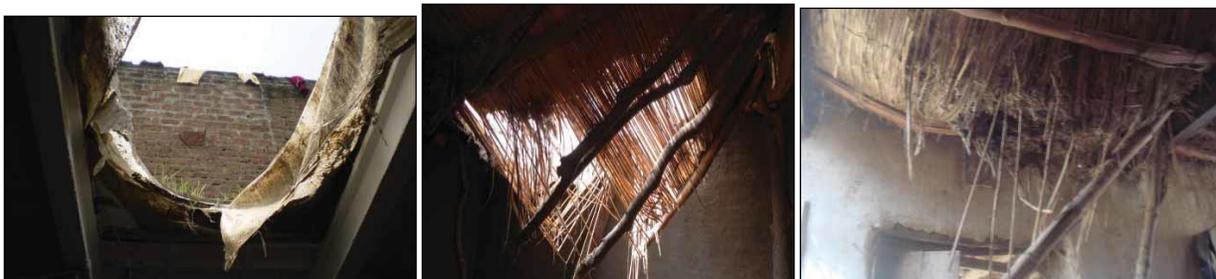
The collapse of roofs remained another major cause of damage. Due to saturation of the mud roofs with no water proofing, the dead weight of the roofs increased substantially leading to the sagging to wooden roof structure and ultimate collapse. In Figure 6, some of such houses are shown.

Fig. 6. Damaged roofs of the mud houses.

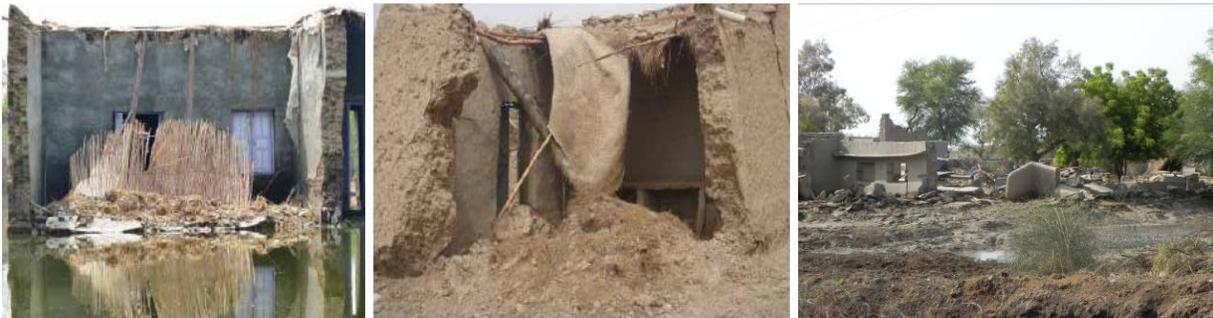
In some cases, the houses have been completely wiped out by the floods. Most of such houses were constructed in the flood plains. In some cases, the collapse of the roofs also caused the major damages. Some of such houses are shown in Figure 7.

Fig. 7. Flood damaged houses due to wiping out of houses mostly located in the flood plains.

Most of the mud houses collapsed during the floods 2010 was located in the flood plains. The site selection is of prime considerations in the construction of mud houses. For construction of mud houses, the raised and elevated platforms are more suitable to avoid threat to the buildings. The soil must be well compacted.

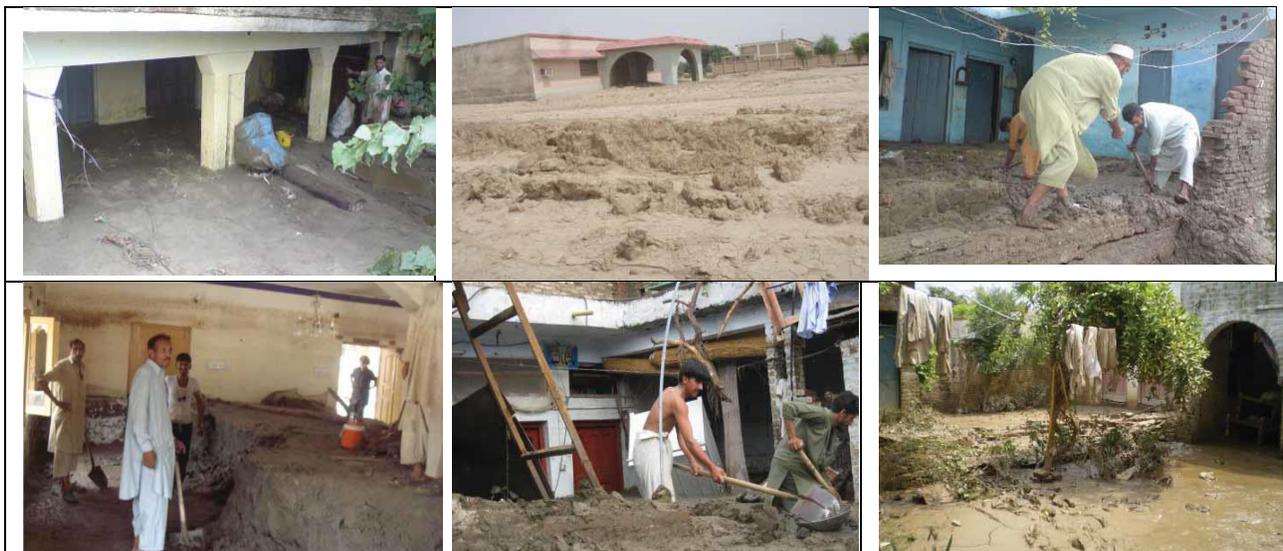
After receding of flood water, the debris mostly comprised of silt and clay remained dumped in the houses for long time, which also damaged the houses. The clearance of the debris remained a major post flood activity in the

affected areas. In Figure 8 the debris in the houses are cleared by the residents and volunteers.

Fig. 8. Damaged houses due to deposition of debris after floods.

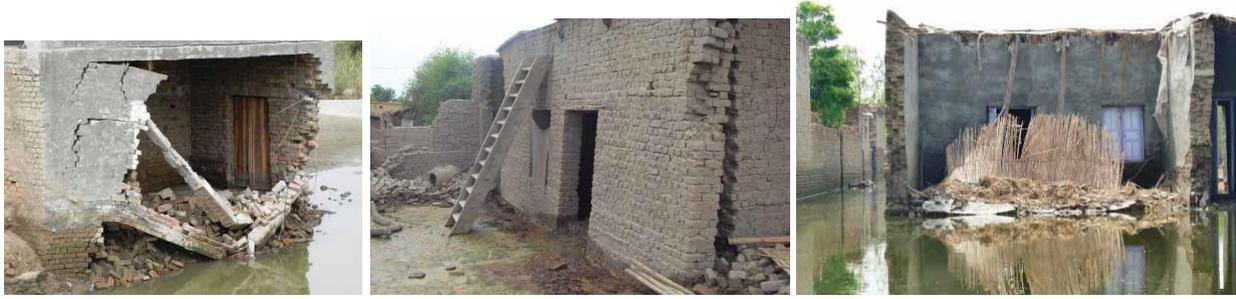
In plain areas, having no proper drainage, the flood remained standing for months, which has been eroding and undermining the foundations and other parts of the substructures of mud houses leading to collapse of walls. This is more common in the areas located in thick populated settlements, where drainage of water is relatively difficult. In Figure 9 some houses damaged due to standing waters can be seen.

Fig. 9. Effect of standing water on the mud houses.
