## Deep-seated mass rock creep along the Karakoram Highway and its geomorphological consequences in the Middle Indus Valley near Chilas, Northern Pakistan

**ABSTRACT:** *Unexpected sudden landslides along the Karakoram Highway (KKH) are a common and feared phenomenon, but the causes have scarcely been related to processes of persistent rock creep, which are to be presented here. Mass rock creep in motion cannot be experienced by direct observation because of being an extremely slow type of mass movement; the rate of velocity measures only ~ 1-10 mm/a. However the results of these extremely slow rock movements are morphologically conspicuous and important from the point of view of engineering geology, especially along glacially eroded valley flanks as in the case of the Indus valley course in question.*

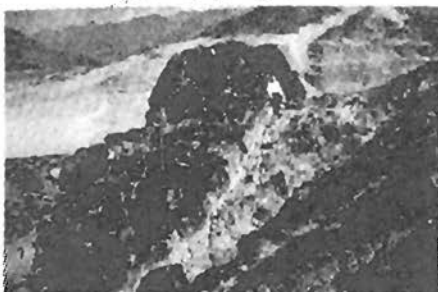
Plate 1. This peculiar outstanding rock at the mouth of Hodar creek (Site 1) demonstrates the typical toppling phenomenon with an uphill facing scarp. As indicated by arrows this giant block has rotated out of the slope towards the Indus valley (left) by app.  $45^\circ$ , from right to left side in the picture. Lack of desert varnish at the base of the antithetic fault plane (light coloured zone at legs of person) points to a still ongoing process of tilting.

This site may illustrate the nature of a pure toppling feature. The most interesting outcrop is given there by a strangely prominent outstanding slab of rock. It represents a surprising feature of local relief at the outermost end or spur of a glacially abraded smooth ridge. As one can see on the picture (Plate 1) it abruptly rises to more than 5m at the downslope side and still seems to move by rotating out of the slope and turning down to the valley. The lack of varnish at the rim suggests an ongoing movement. At any rate this curious rock represents a classical toppling from postglacial time. The kinematics can be understood by studying Plate 2, which shows how the antithetic faulting took place, namely with the rock left of the steep shear zone moving upward relative to the right side, eventually forming an antislope on the mountain side.

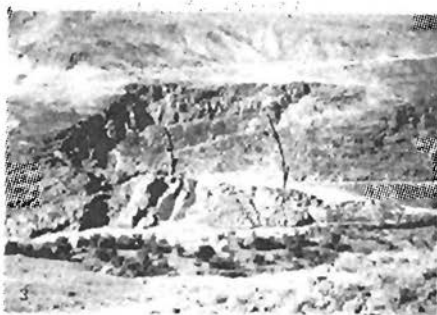
Plate 3. This aerial picture facing a planar slide (Site 2) E of Thak Gah creek was taken from the opposite Indus valley side, near Thalpan village. The Indus river is visible in the lower part of the picture running from left to right (E - W) adjacent to the slide mass. The latter one has slid on a listric shear plane and thereby has rotated laterally, forming an angle of  $\sim 30^\circ$  as indicated by arrows; on this assumption the structure of the slide mass would fit onto the head scarp.

Just W of the Thak Gah tributary, where the Indus river has a stoss side on its precipitous concave bank, a well developed example of a rock slide can be observed (Plate 3, 4). The shear surface shows a listric bending (level of the Karakoram Highway), which is situated more than 30m above the Indus waterline. The slide must have moved slowly by laterally rotating in the manner of opening scissors. This can be inferred by the preservation and final position of the slide mass at the river side (Plate 3). Moreover, as the slide appears to be derived from the margin of a large glacially moulded rock, a *roche-moutonnée* (left part of Plate 4) it seems probable that the slide occurred after the last valley glaciation (VOELK & SCHMELZER in prep.). From Plate 3 it can be deduced that the presumed *roche-*

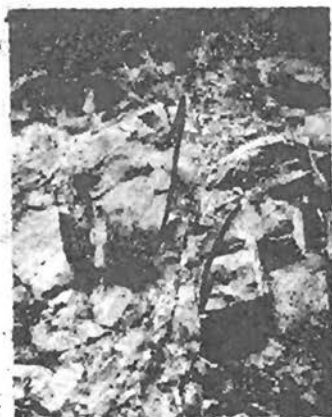
Plate 2. Detailed picture of an antithetic fault movement toppling indicating typical gravitational toppling mechanics in connection with Plate 1, Site 1, Hodar. The slope is descending to the left (riverside). Note the crashing and partly grinding of hard rock into rock powder or fault gouge along the shear surfaces. The left part of outcropping rock, weakly foliated, has moved upward relative to the right part along a vertical shear zone (cf. Fig. 2 a, b).

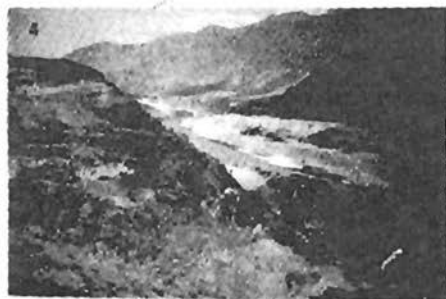
Plate 4. This picture shows the same site as Fig. 4, but viewing the Indus river downvalley. It demonstrates the isolated slide mass, which is separated from the upslope area by a trench (highway). Note further the rocky hills surrounded by alluvial sand and gravel at the opposite river bank. They are assumed also to have moved gravitationally from an upslope area down to the floodplain, because they show the typical fracturing pattern of the rock mass.

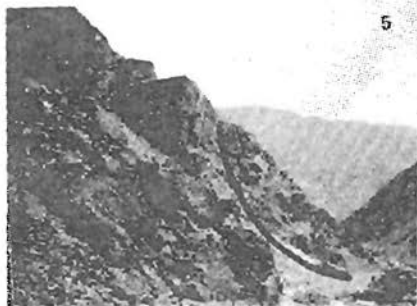
Plate 5. A view upon the left side of Giche Gah creek (Site 4), inside the tributary downvalley to the main river Indus in the background. It shows a typical example of gravitational slope deformation: firstly in the upper slope two trenches with uphill-facing scarps produced by toppling movements (thick arrows), which have resulted in an oversteepening of the foliation (stippled lines); then a secondary toppling-induced initial sliding (thick arrow) below a downhill-facing scarp and finally bulging of the lower middle slope. The bulging has been produced by dilation due to extensive fragmentation of rocks into coarse blocks.

Inside the tributary valley of Giche Gah creek the author encountered an instructive example of slope deformation in a transitional stage between toppling and initial sliding (Plate 5). Below a sharp break of valley slope - accomplished by an antithetic shearing of rock up- and outwards (toppling) on a rather steep rock face ( $\sim 60^\circ - 70^\circ$ ) forming conspicuous antislope - one finds a downhill-facing slope exhibiting rocks with an overturned foliation structure due to the antithetic outward rotation. Just downwards of the scarp the slope bulges and shows a rock mass disintegration by visible coarse fragmentation. Traces of listric fault planes in the lower part of the slope indicate an initial sliding movement.

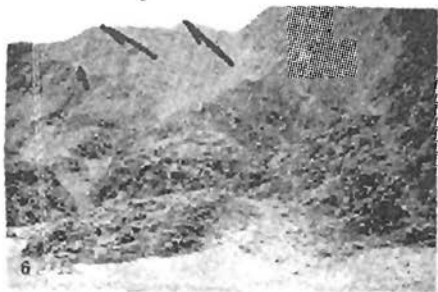
Plate 6. The southern valley flank of the Indus river near the village of Minergha (Site 3) is characterized by several trenches, which interrupt the flank and show uphill-facing slopes on the downward side of the trenches, indicated here by arrows. These features are assumed to have originated by toppling movements. Note the coarse, locally even blocky slope (cf. Plate 7)!

This site represents the first example of a series of more complex slope deformations (Site 3 - 7). Viewing the Indus valley slope to the E of Miner Gah from a distance we recognize a valley flank which is interrupted by a set of trenches in a mesoscalic dimension (Plate 6, upper left). Taking a closer look at the slope surface we discover an extraordinary roughness of the superficial aspect; which is caused by an intense joint system crossing a well developed foliation or "layering" parallel to the slope (Plate 7, upper left).

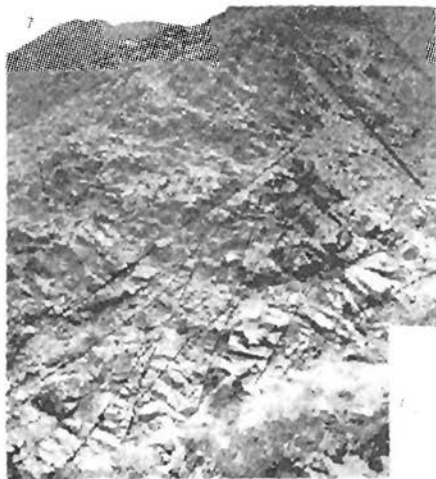
Plate 7. This view shows a slope profile of site 3 (Plate 6) in more detail looking upvalley along the Indus valley flank. The primary toppling movement (thick arrows) at the upper right of the picture has produced a break in the slope. Innumerable joints (from upper left to lower right) parallel to the toppling shear plane cross cut the foliation which runs more or less parallel to the slope (from upper right to lower left). This kinematic might explain the rectangular fragmentation of the exposed rocks. Note the combined secondary movements of slippage oblique to the foliation (lower part of picture) leading to wedges and incipient shear pods (German phacoids) along a zone of moderate inclination (app.  $45^\circ$ ) towards the thalweg on the left, outside of picture.

Our interpretation conceives several stages of gravitational movements: (a) toppling movements, brought about by antithetic faults (thick arrows) together with an intensification of joints including innumerable discontinuities steeply dipping uphill; (b) a toppling-induced sliding along various foliation planes which resulted in an anastomosing system of shear planes and wedging features in the compressional zone at the footslope; (c) a possible repetition of the cycle of movements (a + b), which could have led to overthrusting (thin arrow) of the first cycle near the footslope (Plate 7).

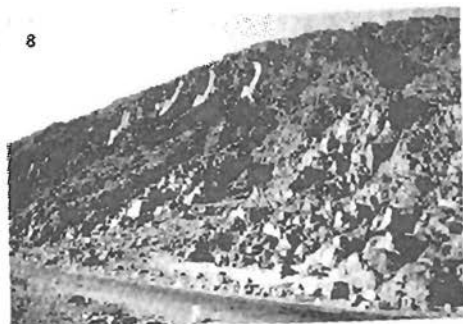
Plate 8. View upon the southern valley flank of Indus river looking up-valley W of Giche Gah creek, site 4. High up in the slope one observes a trench with a large uphill-facing scarp (shadow), which is interpreted as a toppling feature (thick arrow) related to a primary gravitational slope movement. This in turn is followed by toppling-induced sliding and finds its expression by a set of normal fault scarps (thin arrows) at the slope profile near the descending horizon (middle part). These scarps are downhill-facing towards the river bank (out of picture) to the left, a morphology which indicates sliding kinematics. Note also the curious scarplets characterizing the rock slope in the lower part, middle to right in the picture.

The geomorphical situation and the slope kinematics W of Giche Gah Creek are to some extent similar to Site 3 (Minergha), but in this case, Site 4, the foliation is only of minor importance, more widely spaced or almost absent. However, in Plate 10 (left middle part) some traces of relictic foliation can be detected; they run parallel to the slide planes (Plate 10, lower left angle). An overall-look (Plate 8) at the upper slope of the site discloses the primary toppling movement through an impressive trench with its uphill-facing scarp (thick arrow). It is, however, the additional occurrence of a set of downhill-facing scarps at site 9 (Plate 8, upper left) that has made the site so interesting to study, because these scarps point to the existence of (secondary) slide movements and supports the observation of a toppling-induced slide movement subsequent to the first antithetic faulting along toppling rocks slabs. One of these slides is nicely documented by a distinct basal (shear) plane; it is inclined towards the river side and situated on the lower slope (Plate 10, lower left angle).

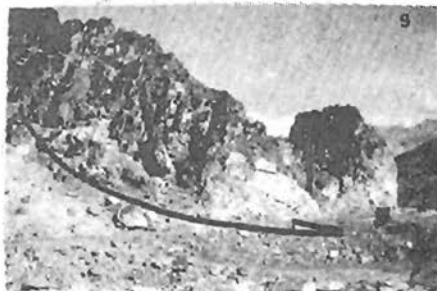
Plate 9. The rock deformation at the footslope of site 4 approaching the Indus thalweg (on right) W of Giche Gah, similarly demonstrates two types of mechanism: firstly, primary toppling of large rock slabs showing sheared joints (thick arrows), steeply dipping to the mountain-side (left), secondly, traces of steep normal faults dipping to the valley side (on right) and being secondary because cross-cutting the former ones. The normal faults are to be connected with a basal slide plane (concave arrow) which is assumed to exist underneath the outcropping rocks.

Plate 9 proves the secondary origin of the sliding motion in two ways: (a) by clear cross-cutting the steep antithetic shear planes and their uphill-facing scarps, (b) by the occurrence of toppling features in a low angle footslope zone ( $< 25^\circ$ ) where topples cannot originate. This logic implies that the topples are not in situ, but have moved downwards via slide motion from their original place, i.e., from a steeper section higher up the slope.

A similar reasoning as for point (b) could explain the toppling features in the very footslope, which is given by Plate 9. There

are two conjugating steep joints to be seen, one set inclined to the hillside (to the left), thus in an inherited antithetic toppling position; the other set is inclined downhill (to the right) and is supposed to represent a "complimentary disruption" as indicated in the model of Savage & Varnes, (1987; Fig. 2c).

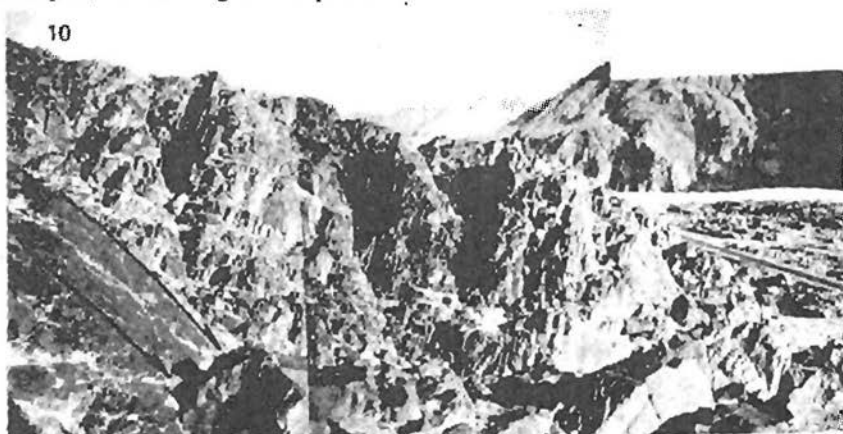
Plate 10. This view down-valley along the Indus river at site 4, W of Giche Gah, exhibits the inferred combination of gravitational slope movements: in massive, only faintly foliated magmatic rocks, somewhat upslope of the situation of Plate 9. Impressive upward-facing scarps of toppling movements (thick arrows) dominate the picture (mainly in the upper section), whereas the slide plane is visible (thin arrows in the lower left) dipping more or less parallel to the relictic foliation at left middle section towards the Indus river bank (at right).

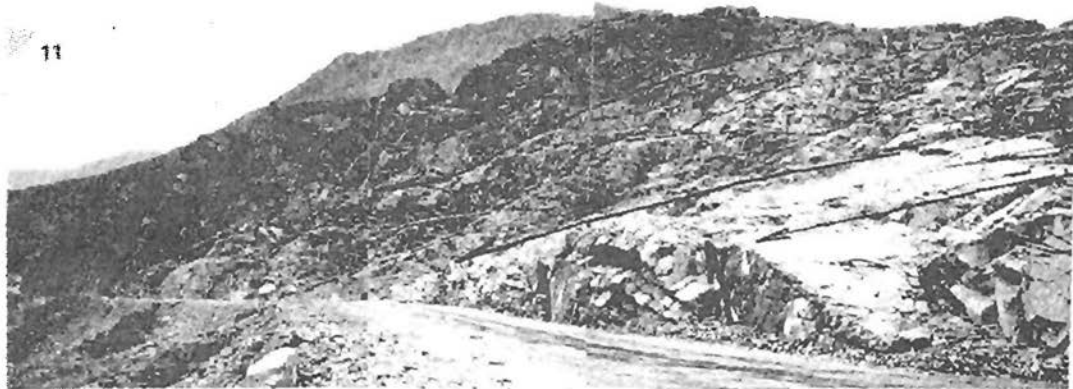
Plate 11. This view shows an outcrop along the Indus river E of Thak Gah creek (Site 6) looking upstream. In the middle part of the outcrop one mainly observes a typical example of a compressional zone with an anastomosing pattern of slide planes showing lenticular shear pods (stippled lines), which stretches with appr.  $30^\circ$  from the upper right to the lower left towards the thalweg of Indus river. Yet below this zone (lower right corner of picture), we recognize short relictic joints steeply inclined towards upslope (short thick arrows), capped by a polished shear plane which functions as a basal plane delimiting the shear pod zone above. Similarly the pattern of discontinuities in the upper part of the outcrop above the slide zone appears to be dominated by steep joints and scarps partly uphill-facing relictic scarps of recently toppling (upper short arrows), partly traces of normal faults. We interpret the rock mass of the outcrop as being not in situ, but emplaced by several slides.

It is assumed, that the site shows two slides upon each other, but separated by a compressional anastomosing shear zone in between (Plate 11). The latter one consists of a series of elongated shear bodies or lenticular shear pods in slight inclination towards the river. The shear pods seem somewhat similar to the bottom features of Site 3 (Plate 7), but the rock material of site 5 appears to be more strongly tectonized regarding the internal fabric (Plate 12). Both slide bodies, underneath and above the shear zone, exhibit steeply dipping joints, which

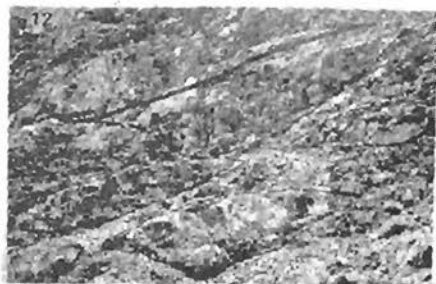
Plate 12. This detailed view of Plate 11 (middle part) is focused on the lenticular shear pods forming a zone of compression at the foot of a larger sliding complex. In addition we are able to recognize intercalated small zones of intensified shear strain showing small scale rock "lenticils", at lower left and lower right of picture. In the foreground a few relictic steep joints can be observed inside a shear pod, which points to a toppling motion previous to the sliding emplacement, when the rock mass was in a steep slope position high up at the valley flank, where alone they can have originated.

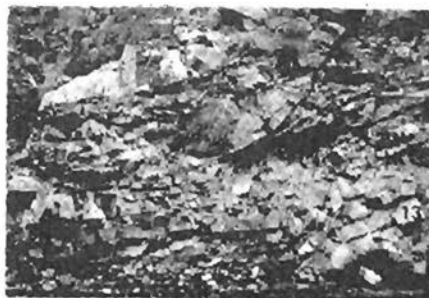
Plate 13. This photograph, taken at the same Site 6, E of Thak Gah creek as Plates 11 and 12, again demonstrates the compressional slide-origin of these rocks. One observes a general shearing movement from upper right to lower left, especially the development of lenticular shear pods (German: phacoids) and of crashing rocks in connection with wedging at various spots in the outcrop. It proves that these rocks are not in situ.

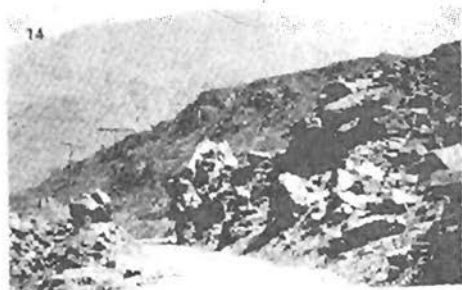
Plate 14. This picture, which is taken E of Thalpan bridge (Site 6) looking upstream along the Indus river (left), shows in the foreground a rugged terrain of rock stacks characterized by steep scarps and joints, running obliquely to the viewer. Note a small relic of a former shear plane obliquely situated at the top of a stack adjacent to the right side of the highway (cf. Plates 15, 16).

This site at the lowermost footslope near the recent Indus river incision can demonstrate the present collapse of highly strained slide remnants forming stacks (Plate 14), which obviously overlie a distinct low angle ( $<25^\circ$ ) shear plane (Plate 17). Regarding these stacks of brittle, highly fractured rocks we easily recognize the disintegration of these rocks (Plate 15 and 16) along their fissures. This strain occurred mainly on account of toppling movements, although we must realize that the deformation pattern did not happen at the site, but two stages earlier, namely during primary slope movements (toppling) in a much steeper uphill slope. Then, in our opinion, followed a toppling-induced slide towards the thalweg, the observed stacks were part of the rockslide. This can be inferred by two distinct shear plains, one underneath and one above the stacks. At present these slide remnants or stacks have come to rest upon a well developed shear plain showing a polished stair-stepped thrust surface (slickensides) with striations, slickenlines and even crescentic grooves (Plate 17). It is remarkable, as already mentioned, that the stacks even exhibit small relicts pieces of a slide plane as capping surface (Plate 14, 16). This means that the rocks in question were part of a slide with an inherited joint pattern now falling apart.

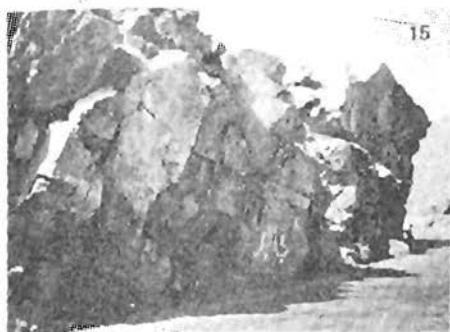
Plate 15. Evident toppling features bound the Karakoram Highway E of Thalpan bridge on the same site as Plate 14, but viewed downstream. The steep open joints are inclined towards the left (mountain side). Some faint features of foliation can be observed in the middle of the outcrop dipping ( $30^\circ$ ) to the right, i.e. to the river side with standing person. The blocky appearance can be explained by the intersection of foliation (= shear) planes, with the steep joint (= shear) plane. These rocks with its wide open fissures represent an extremely released stage at the edge of the river bank being apt to fall apart in the near future (cf. Plate 16). Note, that these rocks are assumed to be not in situ, because they represent a relictic part of a rock slide from the upper slope which rests on a distinct and well documented shear plane (cf. Plate 17).

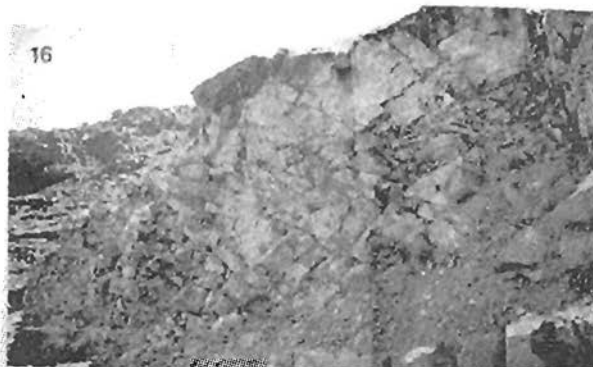
- Plate 16. This picture from Site 6, adjacent to Plates 14, 15 and 17 shows toppling features analogous to Plate 15, but the fragmentation has led to smaller components of rocks, due to an intensified shearing motion, more or less parallel to the foliation inclined to the left (dotted lines) as well as old and now renewed antithetic motion along steep joints. Small relics of a former shear plane (dark coloured by desert varnish) are visible both at the top of the outcrop and at the base (left behind the outcrop). Note that these outcropping dismembered rocks as a whole are not in situ, because they are relictic parts of a series of rock slide masses, which originated from the upper slope and came to rest on the footslope.

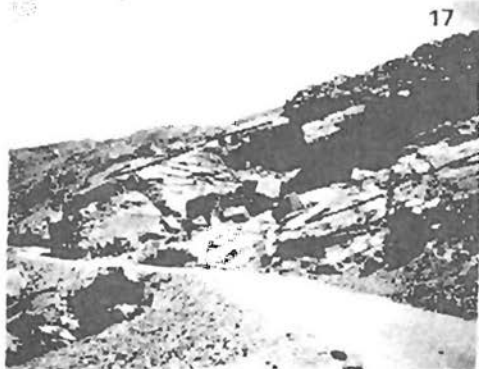
Plate 17. Viewing upvalley along the Indus river, E of Thalpan bridge, Site 6, one recognizes well exposed varnished shear planes with steps and streaks in the foreground, dipping towards the thalweg, left side. Relicts of the slide masses, which have overlain and created these planes in the past occur in the immediate vicinity in the form of those isolated stacks of rock as depicted in Plates 14, 15, 16.

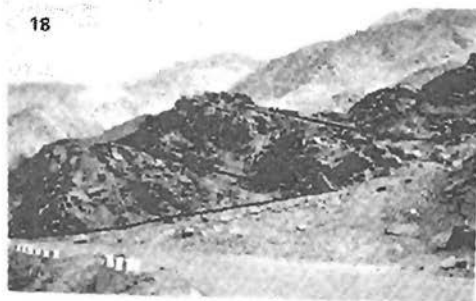
Plate 18. Profile of a protruding slide complex (cf. Plate 20) further E of Thak Gah creek, Site 7, looking upstream along Indus river (left, out of picture). We find three kinds of gravitational movements: in the first place a set of slides thrusting upon each other (arrows); secondly, a set of steep (vertical) joints as relictic features of toppling motion from the original previous upslope position. Thirdly traces of downhill facing scarps (rupture surfaces) and steeply inclined joints (shear planes) at the very left of the complex near the river side. The slide complex appears to have advanced unusually far across the river course (cf. Plate 20).

About 4 km E of Thak Gah creek one encounters Site 7, which is suited to describing a typical distal position of a toppling-induced slide along the KKH. We meet a low level area with a very rugged micro-relief stepwise ascending from the Indus river bank to the mountainous background at some distance (Plate 18, foreground). At first sight, the most variably deformed rocks seem to confuse the spectator, who also observes - besides many steep joint structures with varying dip direction - some subhorizontal structural features (Plate 19). The exposed rocks obviously represent a coexistence of toppling and sliding features, similar to the considerations for Sites 3 - 6. The author recognizes an overlap of slides separated by thrust planes (Plate 18). Nearest to the river side the compressional situation is currently converting into a renewed extensional one, due to ongoing river incision.

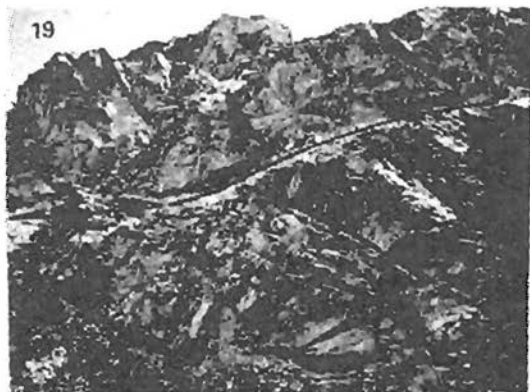
Plate 19. Detailed part of Plate 18, Site 7. It demonstrates again that these rocks are not in situ, but originated from gravitational sliding movements. In the lower and upper section one observes diverse directions of foliations and joints (thick arrows), mainly dipping uphill (to the right). The upper section separated from the lower one by a shear plane (thin arrow), shows similar features, but is different in detail. It is assumed, that the outcropping rocks represent a set of slides with relictic toppling features derived from a much higher and steeper upslope area. The mass has come to rest on the flat footslope approximating the Indus river (cf. Plate 20).

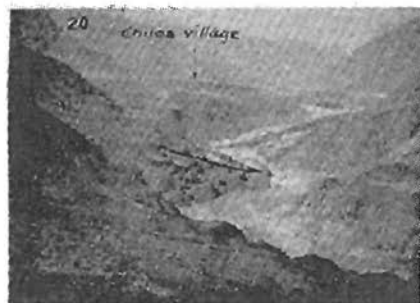
Plate 20. This aerial photograph viewing downvalley shows the course of the Indus river bending around the protruding slide complex (arrow), further E of Thak Gah creek (Site 7); note a significant swing of the river to the right (middle ground of picture). The village of Chilas (dark streak) appears situated on a large pediment-terrace in the background.

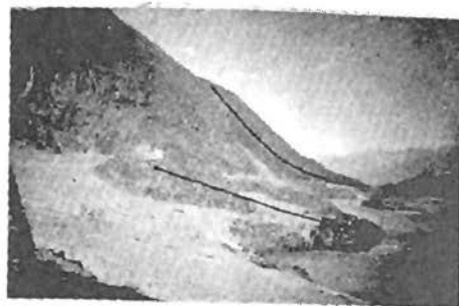
Plate 21. The picture shows the profile of the southern Indus valley flank near the mouth of Giche Gah creek (Site 4) looking downvalley. It demonstrates how the river is forced to bend around advancing tongues of rock creep accomplished by sliding mechanism (arrows). Rock tongue in the foreground is situated just at the mouth of the Giche tributary; note further the dark coloured rock slide tongue in the right / middle background, a few kilometers downvalley, representing again a rock creep-forced river-bend.
