Kaghan Valley (Pakistan) earthquakes of February 14, 2004: source mechanism, intensity distribution and their impact

Abstract

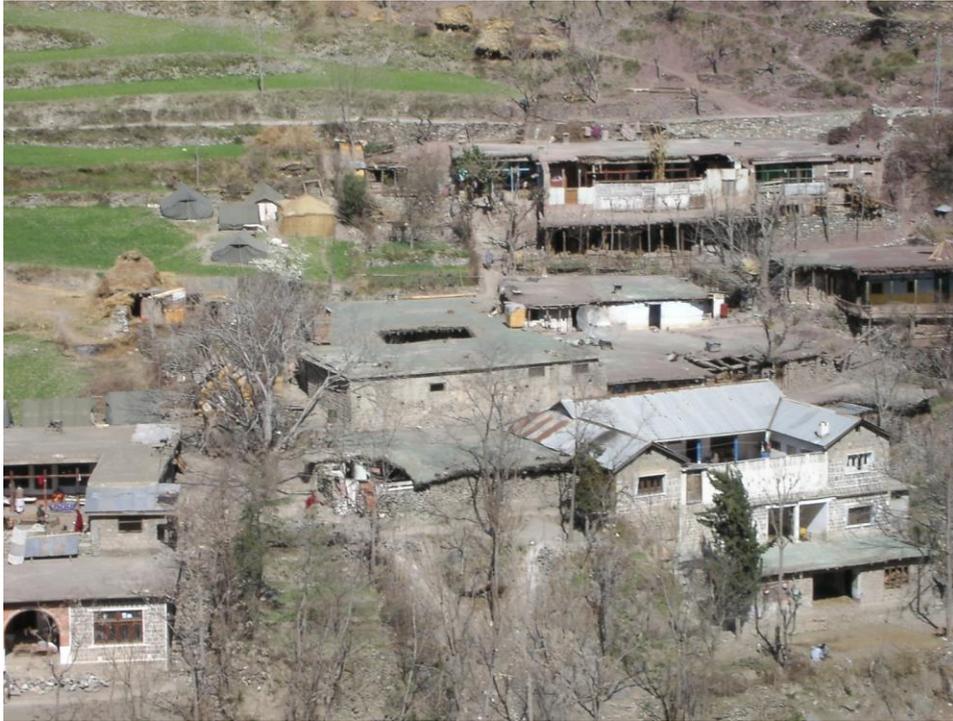
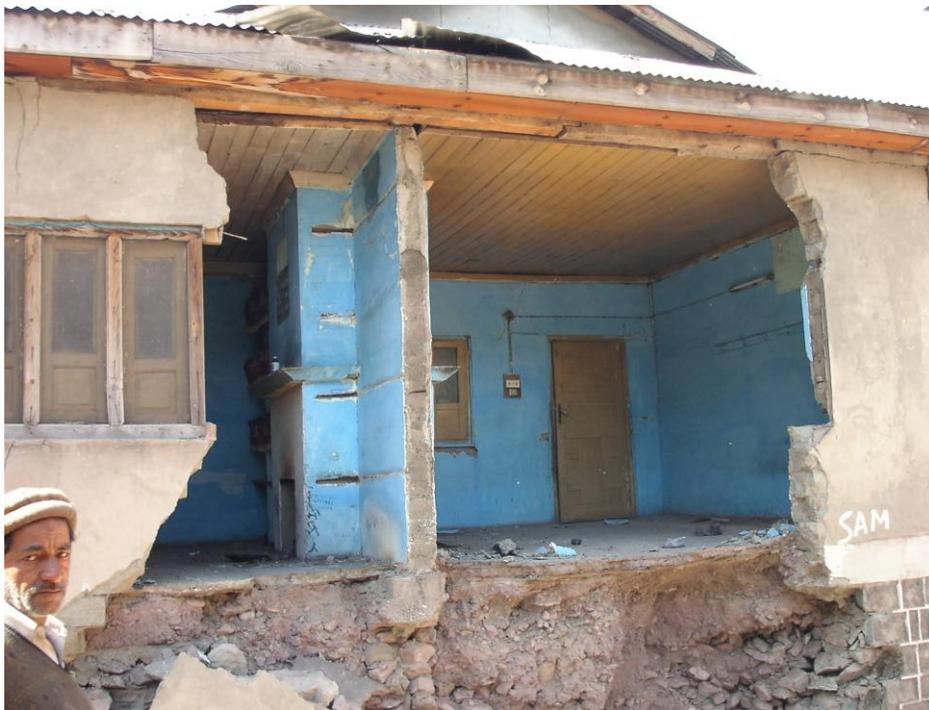
Fig. 4. Photographs showing damage in Paras.

It is a sparsely populated town, located in a steep valley, about 9 km from the epicenter. The MBT passes through the town. Inter-bedded sedimentary rocks (shale, sandstone, limestone) of Salkhala Formation, and Galiat Group are exposed in the area. These rock groups put the upper crust in high seismic attenuation zone. The observed intensity in this area was about VIII on the MMI scale. Intensive shaking was experienced both indoors and outdoors. This caused heavy damage to poorly constructed mud-stone masonry (about 75%) and partial damage to concrete structures (about 30%). The concrete structures founded on steep slopes and/or on fluvial deposits received more damage particularly at the basements while the structures built on hard rocks received lesser damage (Figs. 4 a, b).

According to field investigations, the area of significant damage covered about 1230 km², while the felt area of the earthquakes was about 79750 km². At a few places, on margins of valleys, ground cracks appeared in unconsolidated material generally adjacent to bedrock but apparently with no rupture or displacement of contiguous parts. It may, thus, be concluded that the earthquakes did not cause primary surface faulting. Small scale landslides were reported at numerous places in the valley. Close examination of the crack zones in their geological and geomorphologic perspective suggested that severe shaking of unconsolidated material on the slopes gave rise to cracks and fissures. The villages Paras, Jabbori, Hillkot, Mohri and Karg received heavy damage (Fig. 4 and Fig. 5) both of life and property.

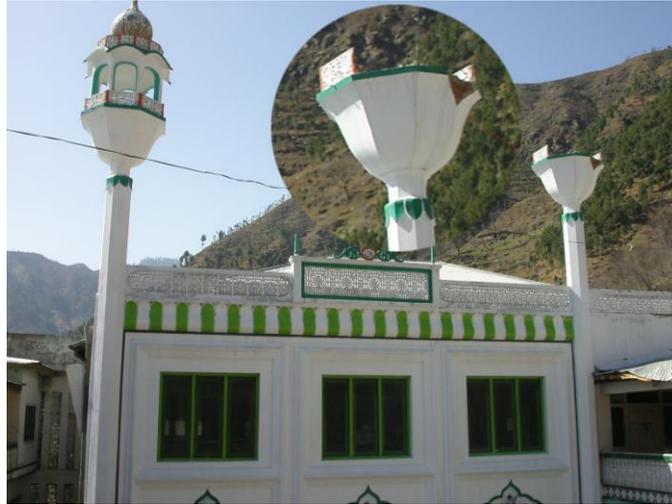
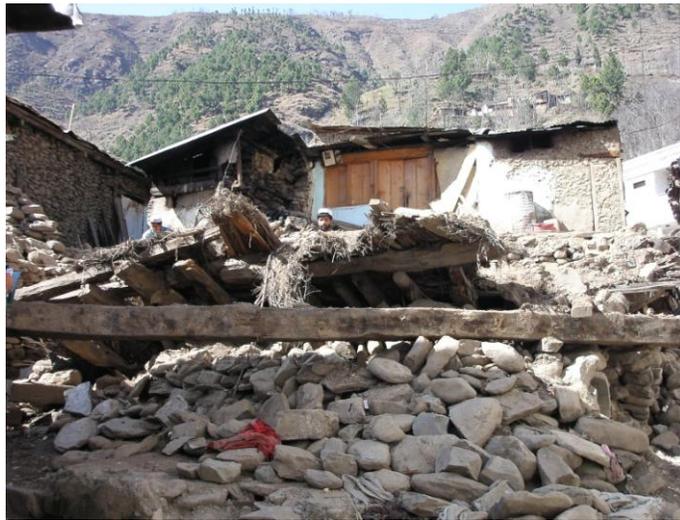
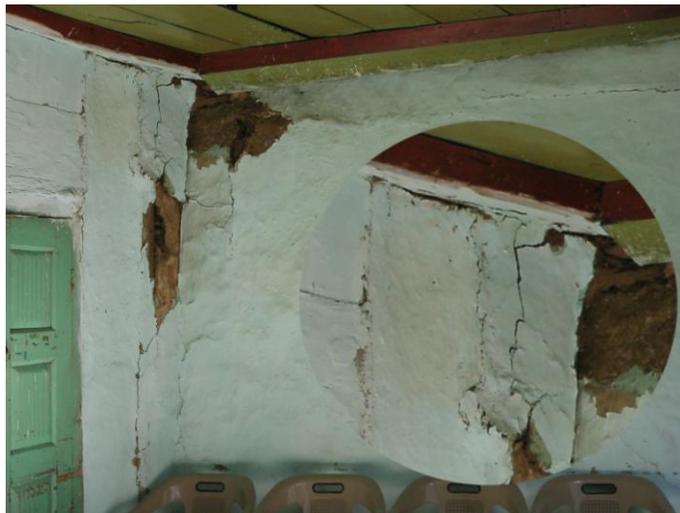
Fig. 5. Photographs showing damage in Jabbori.

This town in Siran Valley is densely populated. It is located about 15 km from the epicenter. The MBT passes about 4 km in the east. Most structures in this town are founded on fluvial deposits of the Siran River that overlie the Mansehra granites. The observed intensity in this area was about VII on the MMI scale. Severe damage to loose masonry construction and some damage to concrete structures was reported (Figs. 5 a, b, c).

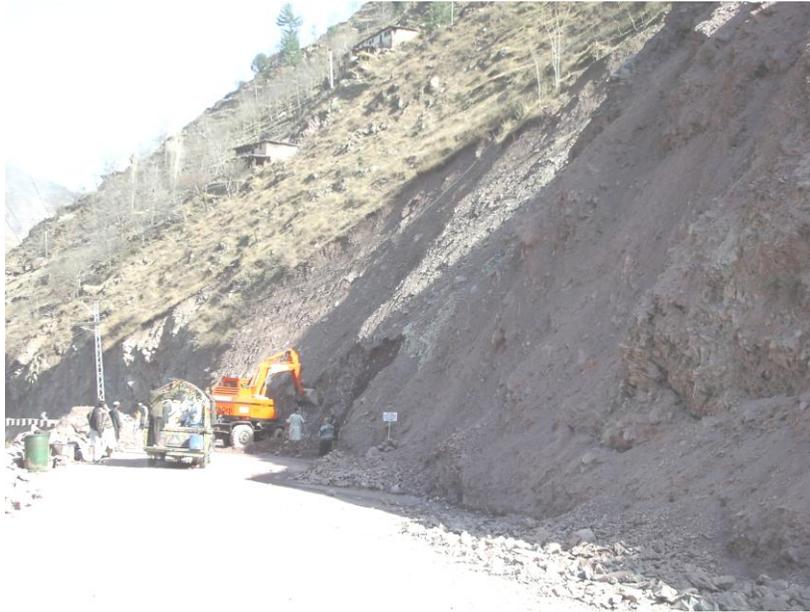
As shown in the geological map of the area, except granites, the lithologies are sensitive to landslides particularly in high slope areas. The landslide prone zone is limited to the mountains and channel banks. As a result of high surface shaking caused by earthquakes at Paras and its vicinity, the stability of natural channels was reduced and many landslides occurred in the area (Fig. 7 a). In addition, several tensional cracks and separation of blocks from main body were observed in the area.

Fig. 7. Photographs showing (a) land sliding in the Kaghan Valley, and (b) subsidence along the road in Paras.

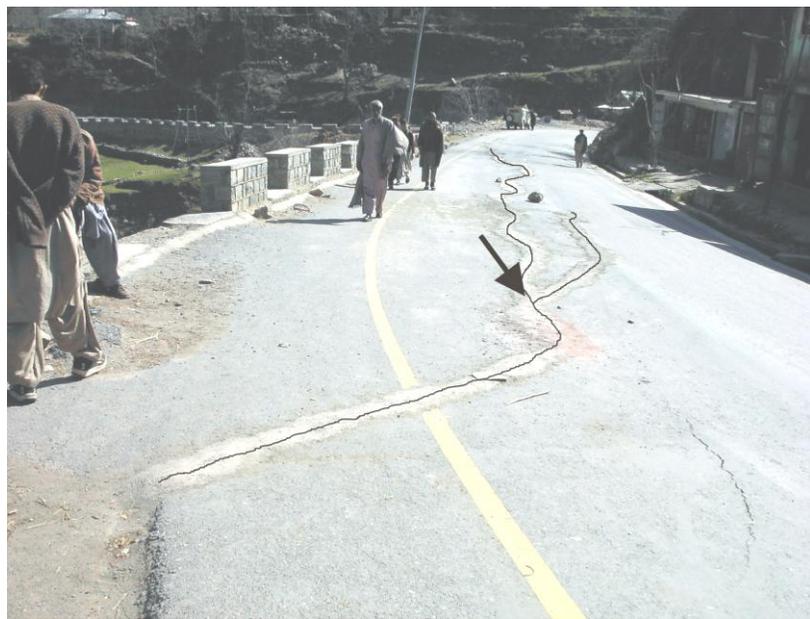
(b)

This phenomenon was observed mainly in soft rock areas particularly on Kunhar Valley slopes cut along the road. This obviously resulted due to poor slope protection of civil structures (Fig. 7 b).
