Earthquake Damage

Mark van der Meijde

Damaging effects of earthquakes

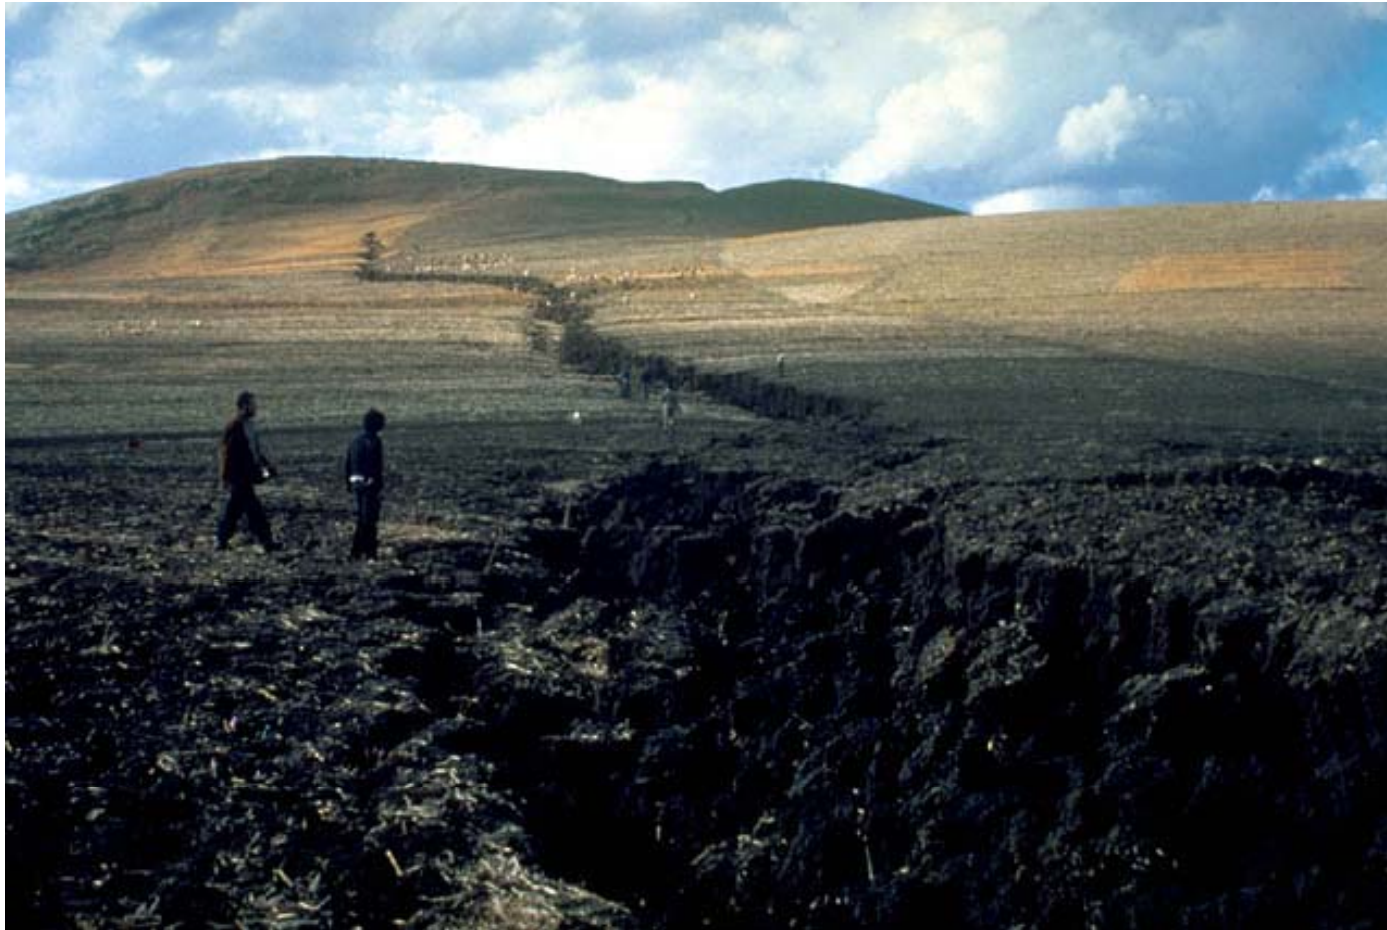
Surface faulting

Normal fault. Scarp near Beni Rached. 1980 El Asnam Earthquake, Algeria

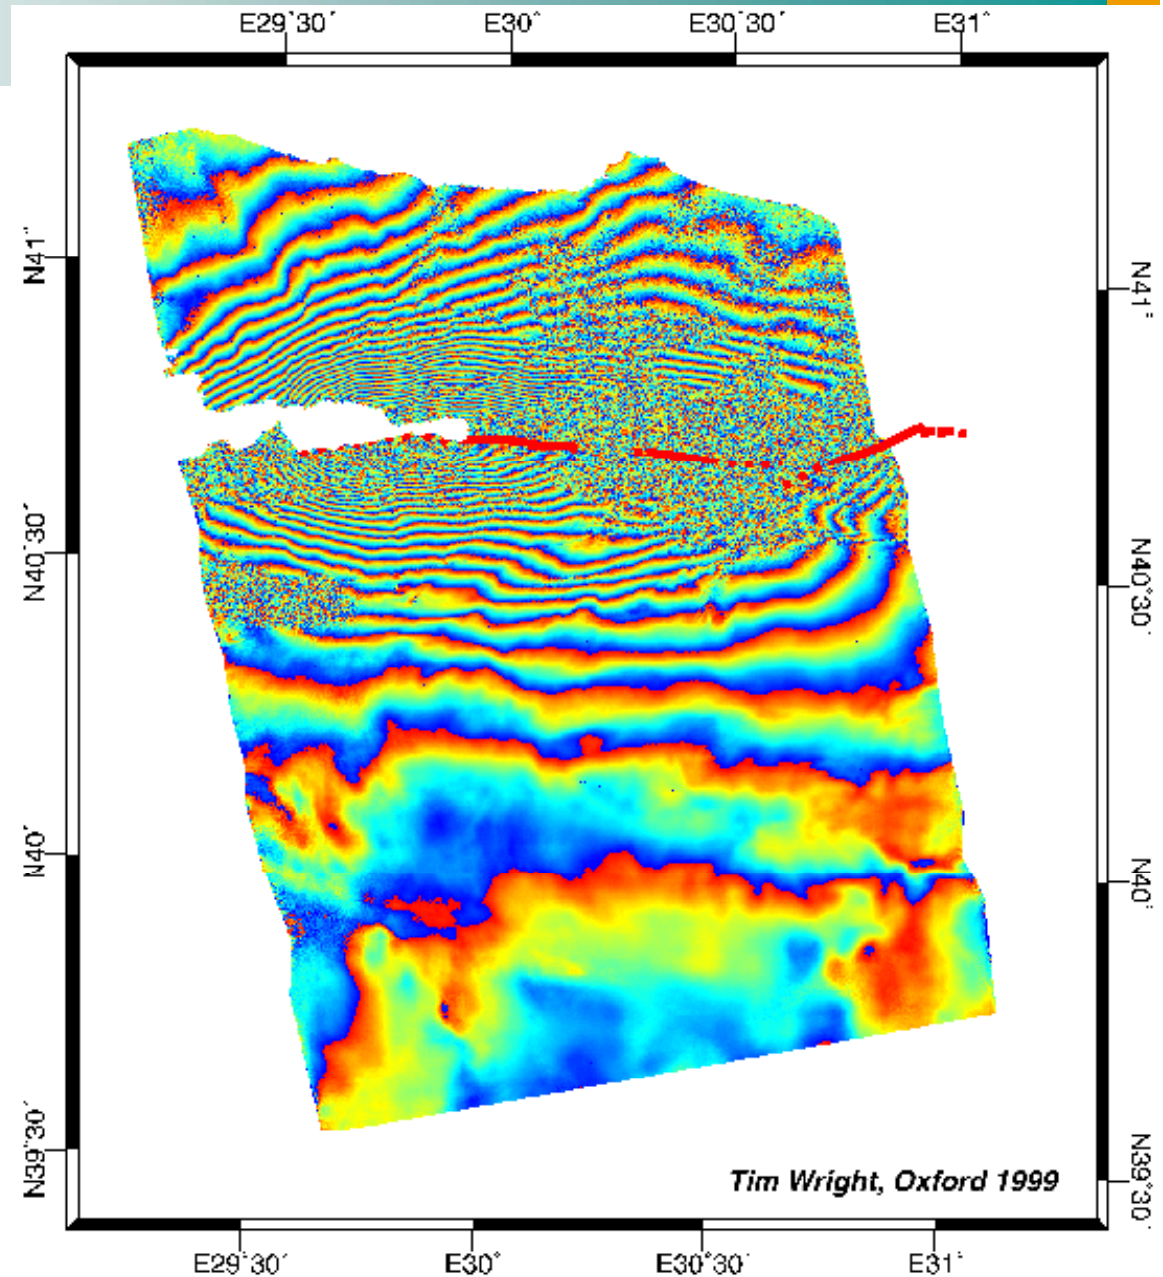
Surface faulting

- The 17 August 1999, Izmit Earthquake
- Displacements from SAR Interferometry

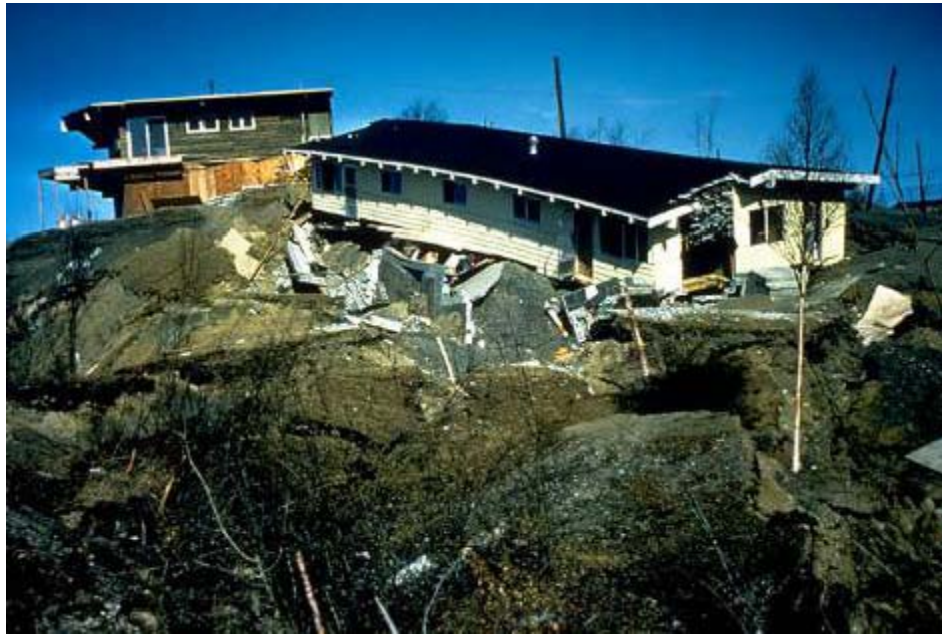
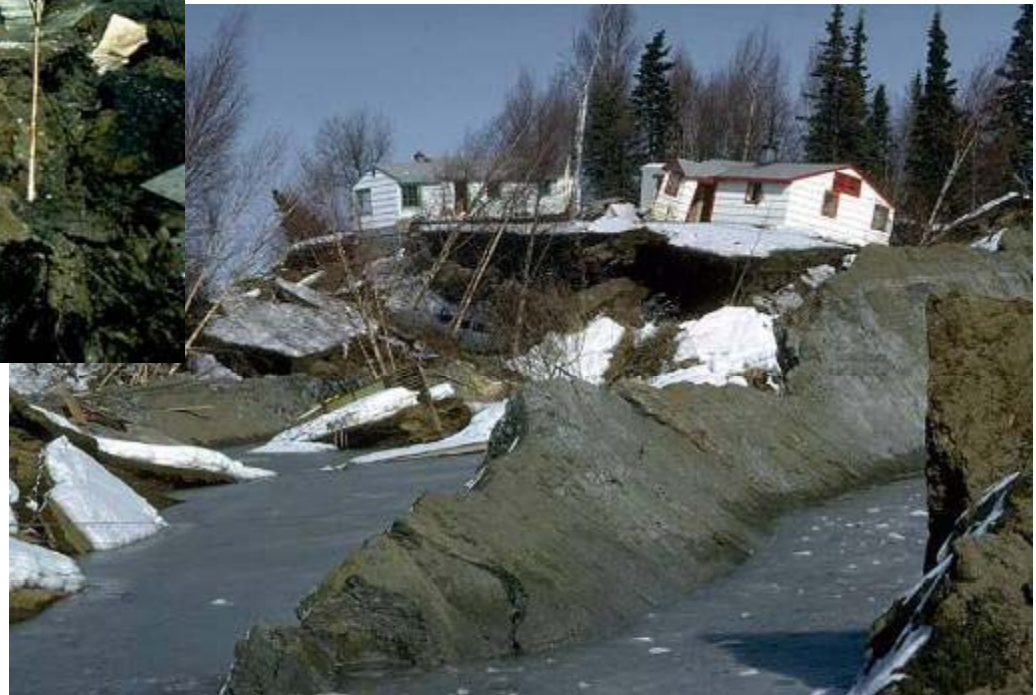
Vibration of soil: Liquefaction

Displacement and tilting of houses due to soil liquefaction in the Turnagain Height area of Anchorage during the 1964 Alaska Earthquake

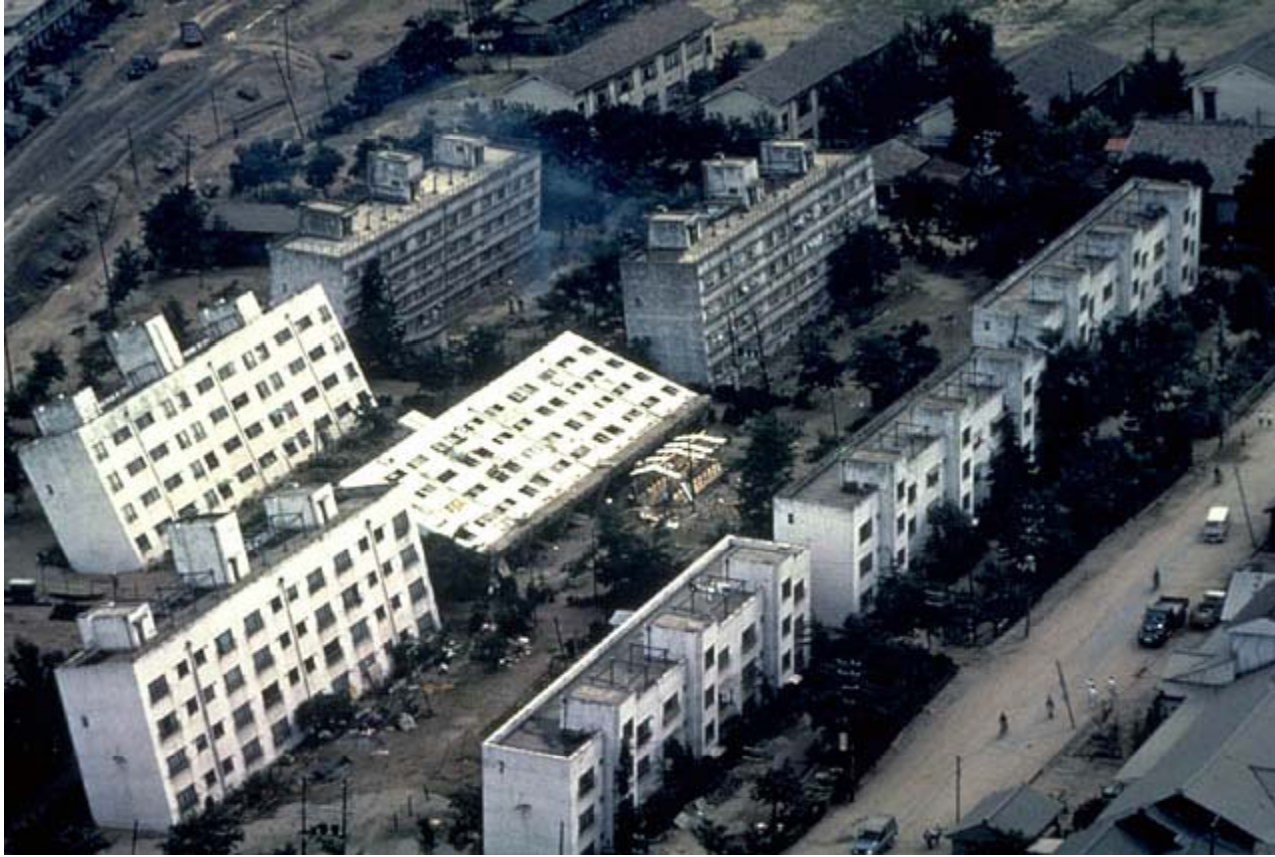
Vibration of soil: Liquefaction

Tilting of apartment buildings at Kawagishi-Cho, Niigata, produced by liquefaction of the soil during the 1964 Niigata Earthquake

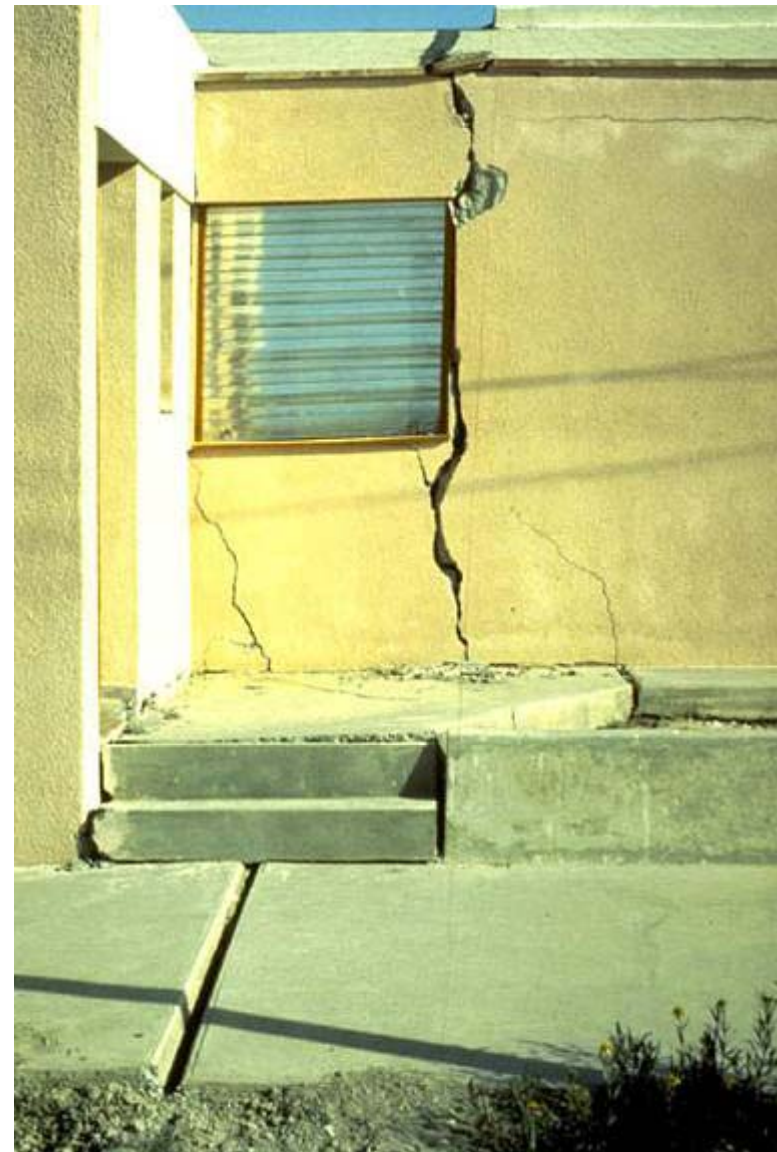
Vibration of soil: differential settlement

One-story masonry house in a main housing development in the town of Caucete, damaged due to differential settlement caused by liquefaction in the 1977 Caucete Earthquake, Argentina

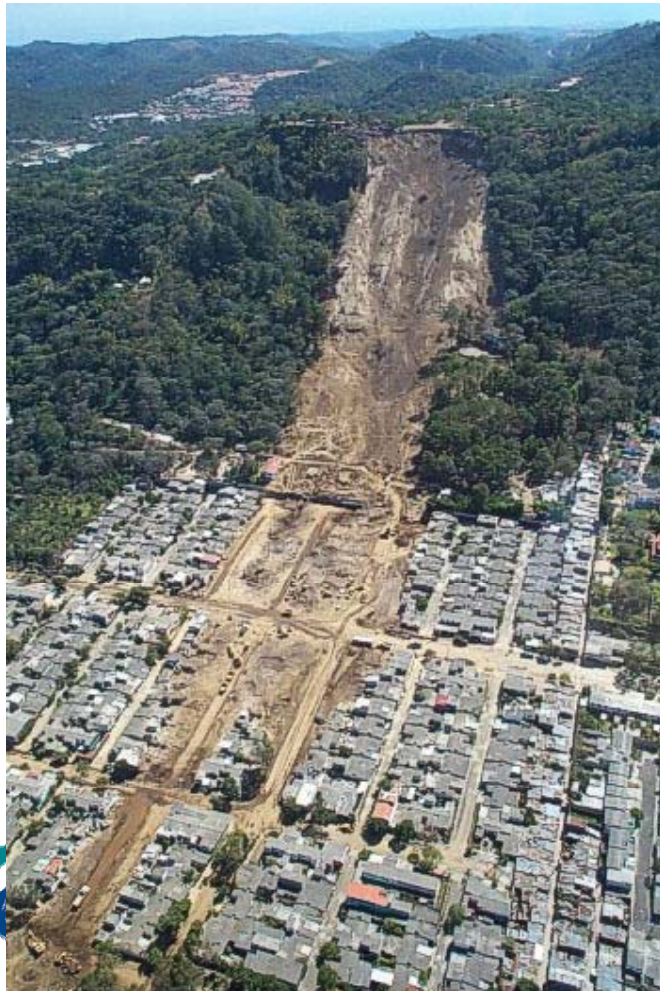
Direct effects: landslides due to topographic amplification

Santa Tecla (Las Colinas)
landslide, Jan 13 2001
earthquake, El Salvador

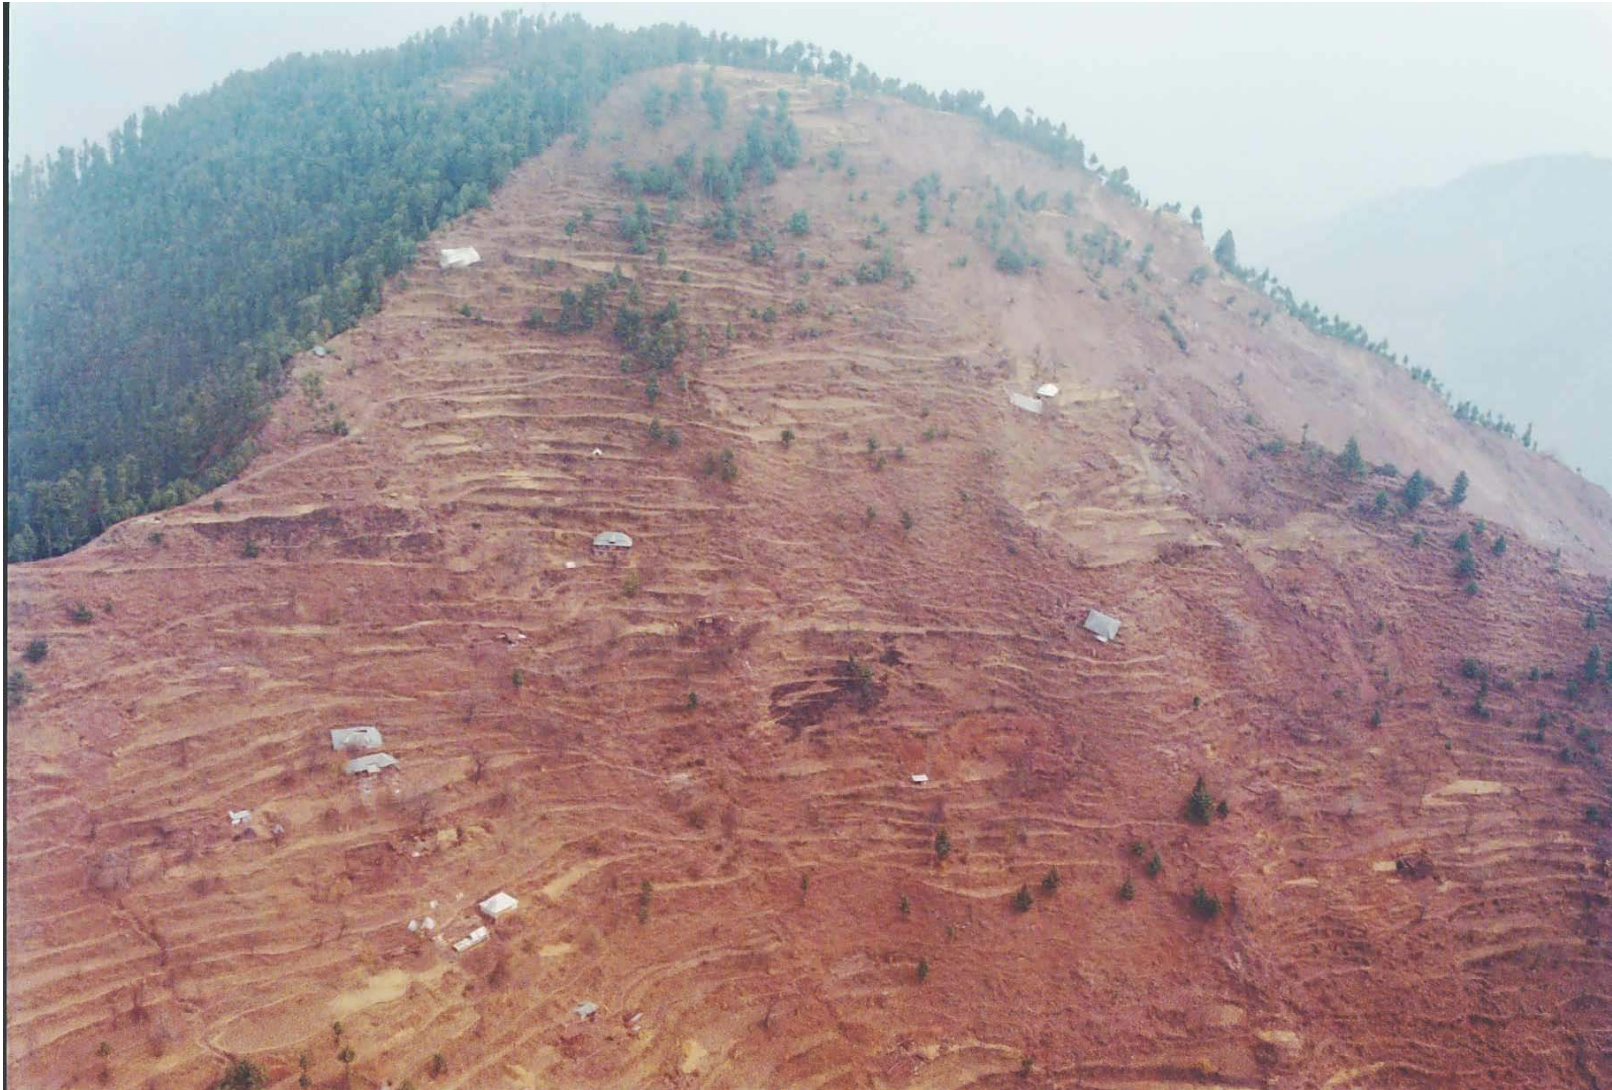
Direct effects: landslides (Kashmir)

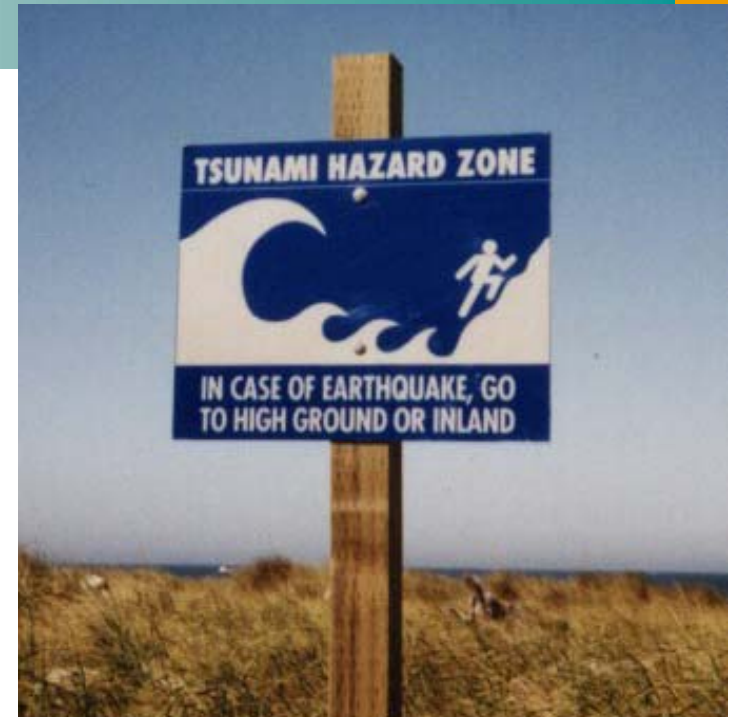
Indirect effects: Tsunamis

- Near-shore or undersea earthquake causing sudden (vertical) movement of the seafloor
- As wave approaches shallow water, it slows down, but energy remains constant, causing waves to increase in height (up to 30 m.)

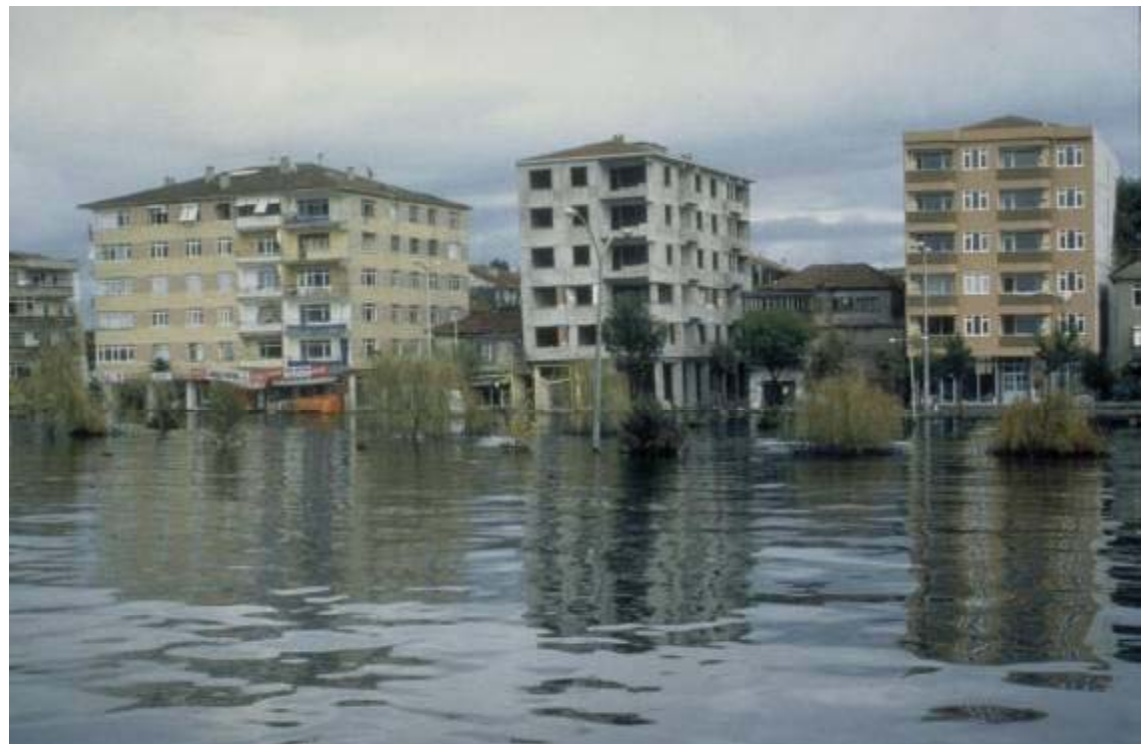
Indirect effects: flooding caused by regional subsidence

- Izmit (Kocaeli) Turkey Earthquake, August 17, 1999

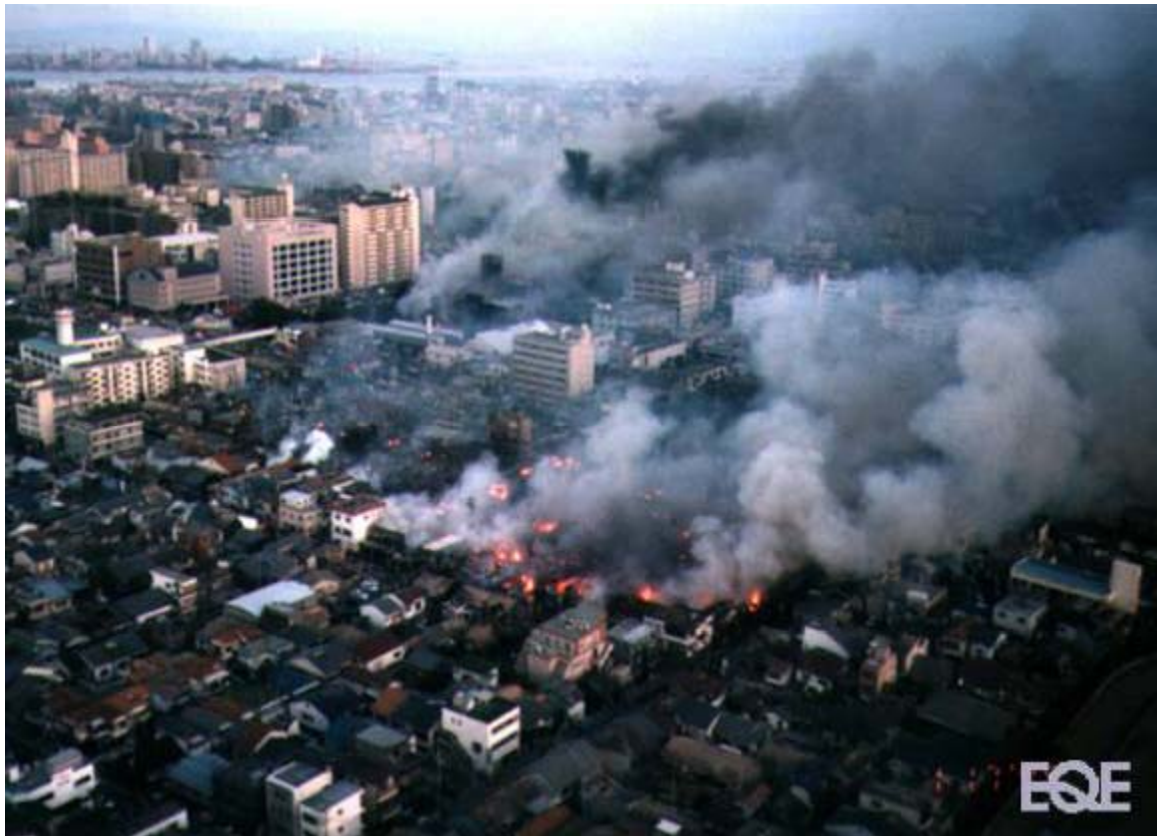
Fire in central Kobe

Large fires following strong earthquakes have long been considered to be capable of producing losses comparable to those resulting from the shaking

17 January 1995,
Kobe Earthquake

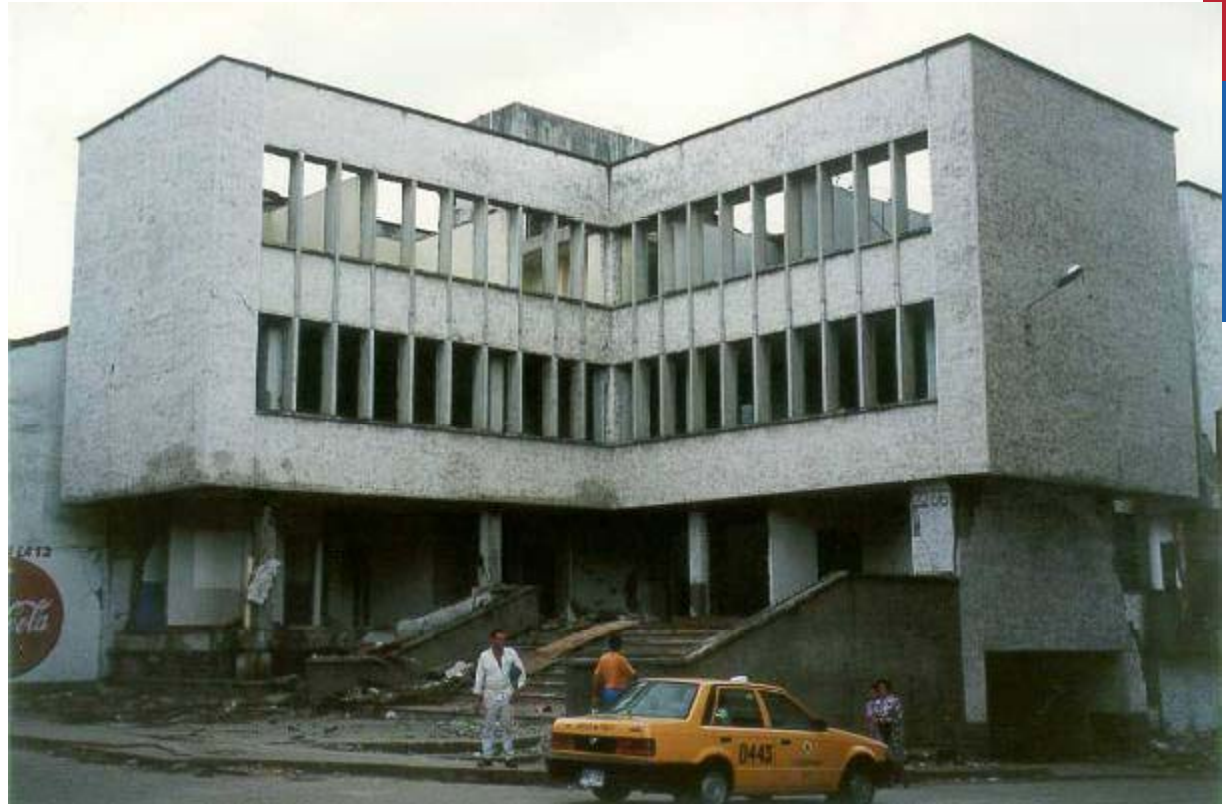
Torsion

Lack of torsional
resistance in the columns
at the periphery of the
building

Armenia, Colombia
25 January 1999, Quindío
earthquake, Colombia
M 6.2

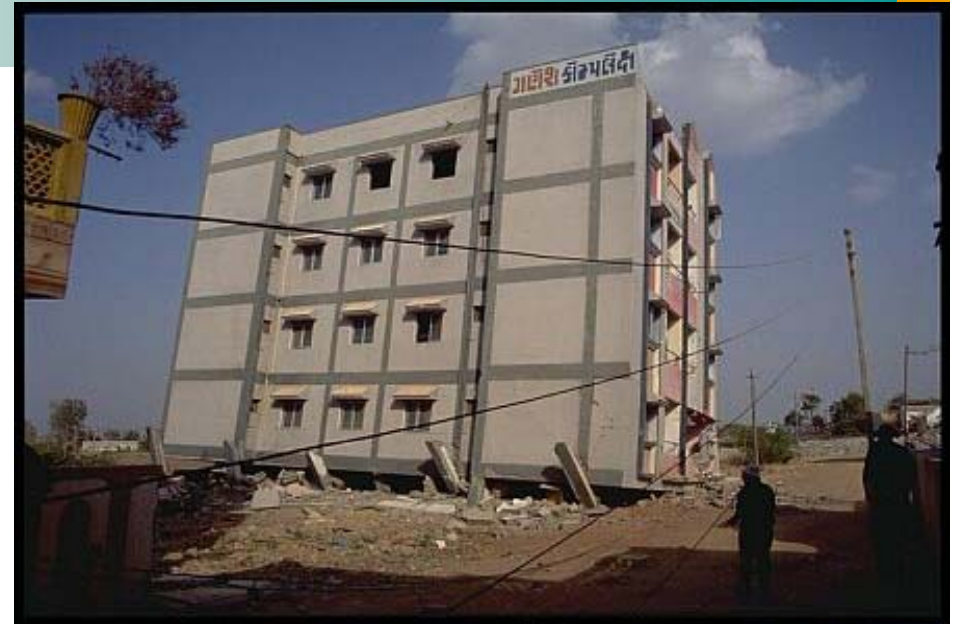
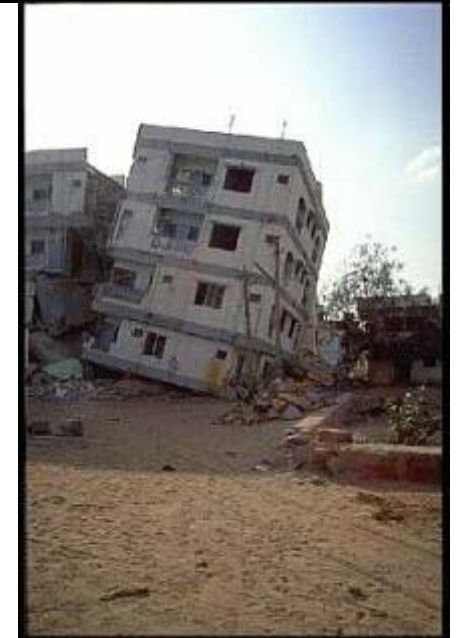
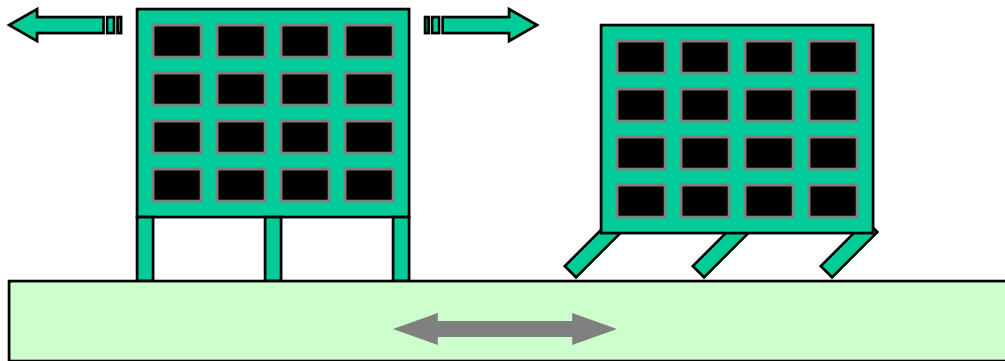
Soft storey

Soft storey: stiffer structural elements which are present in the upper stories are missing at the ground floor - Gujarat earthquake, 26 Jan 2001

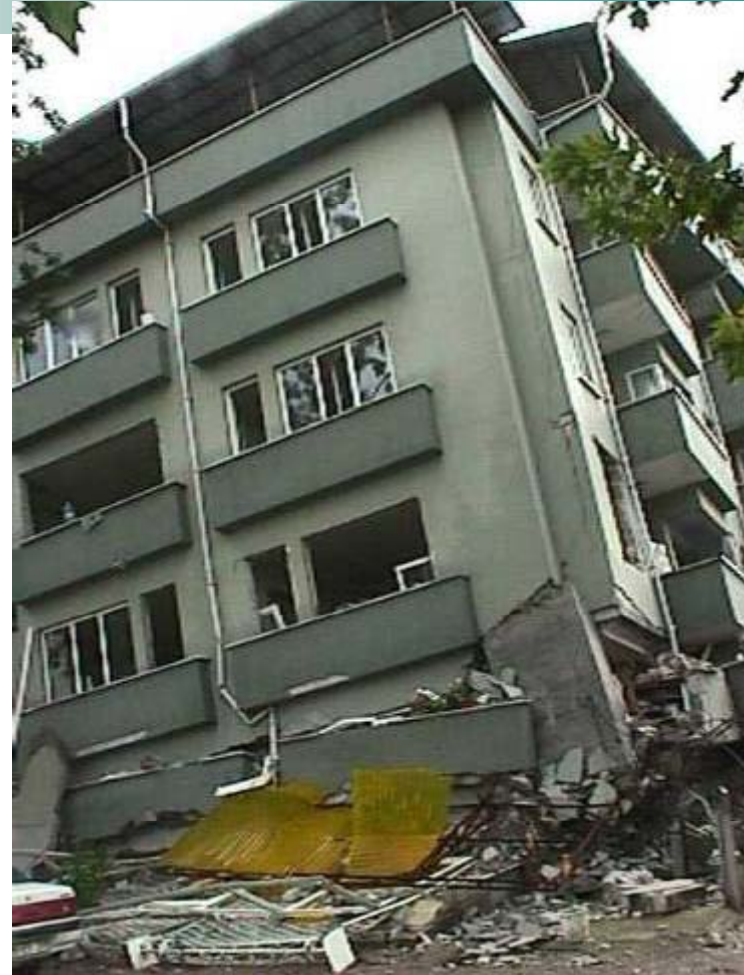
Soft storey

The ground floors of many buildings in Turkey are open spaces reserved for stores and show rooms, with insufficient numbers of columns to support the upper floors – Duzce, Izmit earthquake, 17 August 1999, Turkey (M_w 7.5)

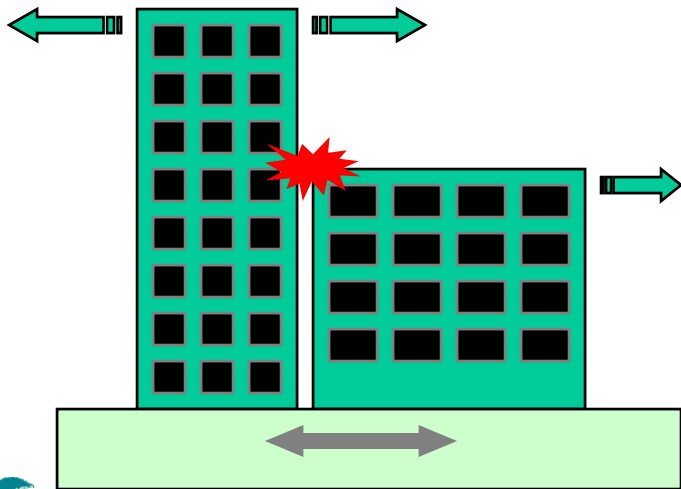
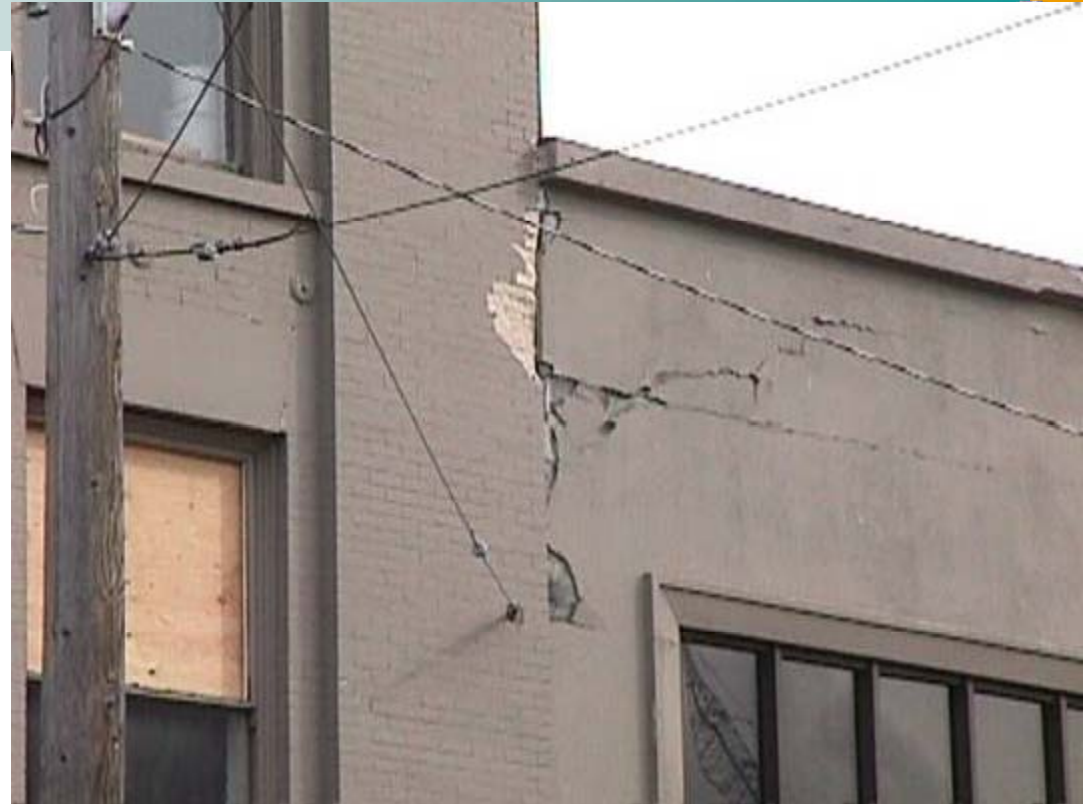
Pounding

- Impact damage
- Asymmetry

28 February 2001, Mw 6.8 Nisqually,
Washington Earthquake

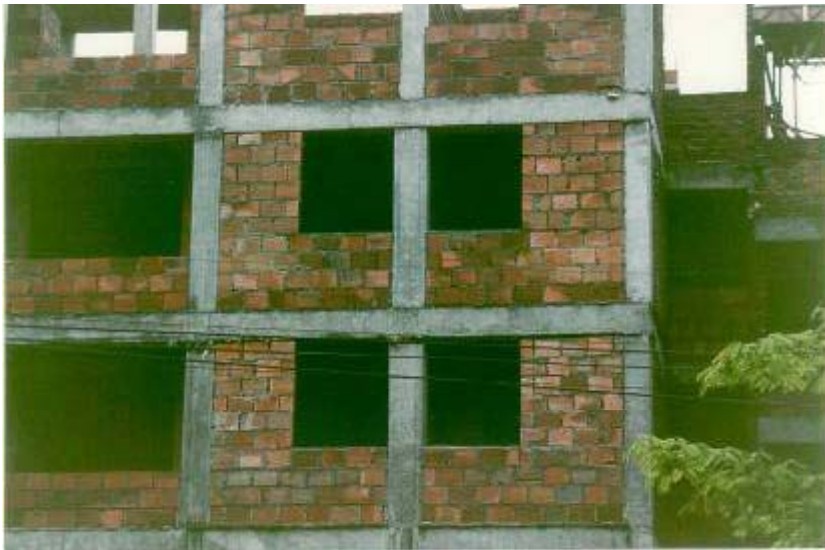
Balcony and inserted brick wall cause short column failure, in combination with bad detailing (lateral reinforcement) - Armenia, Colombia

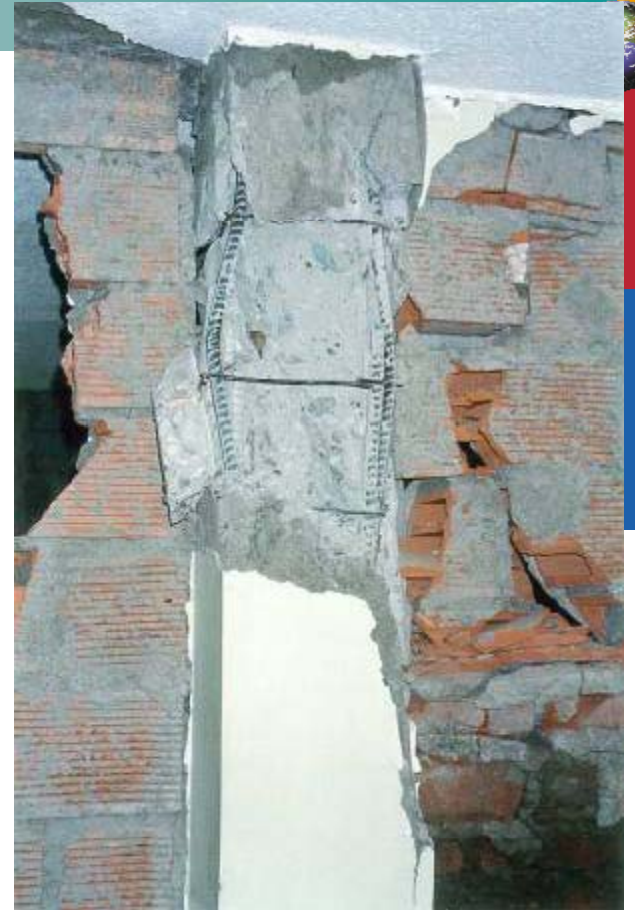
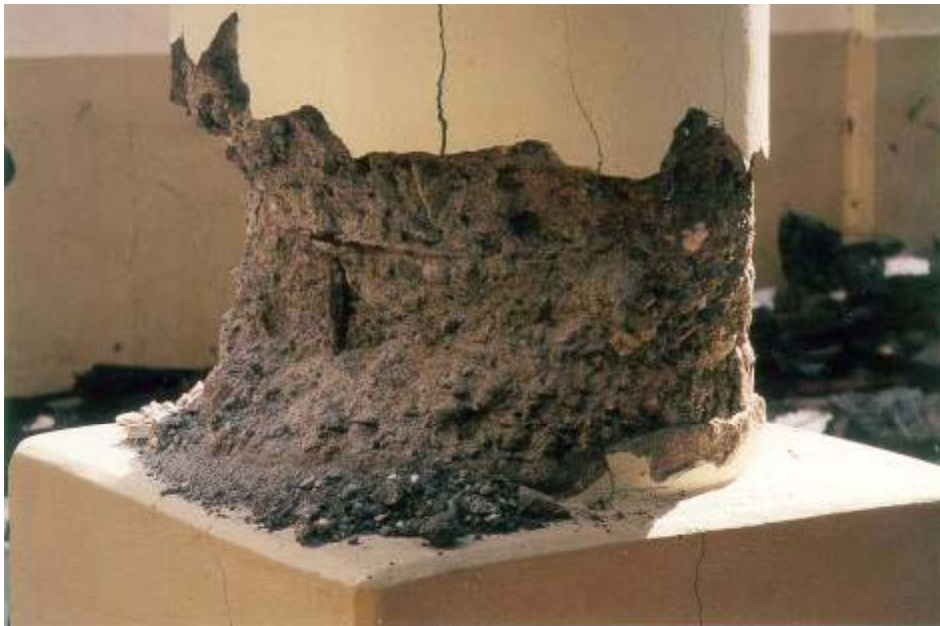
Detailing

Insufficient transverse reinforcement to prevent buckling of the vertical reinforcement

Uninsufficient lateral reinforcement, bad concrete quality, discontinuity

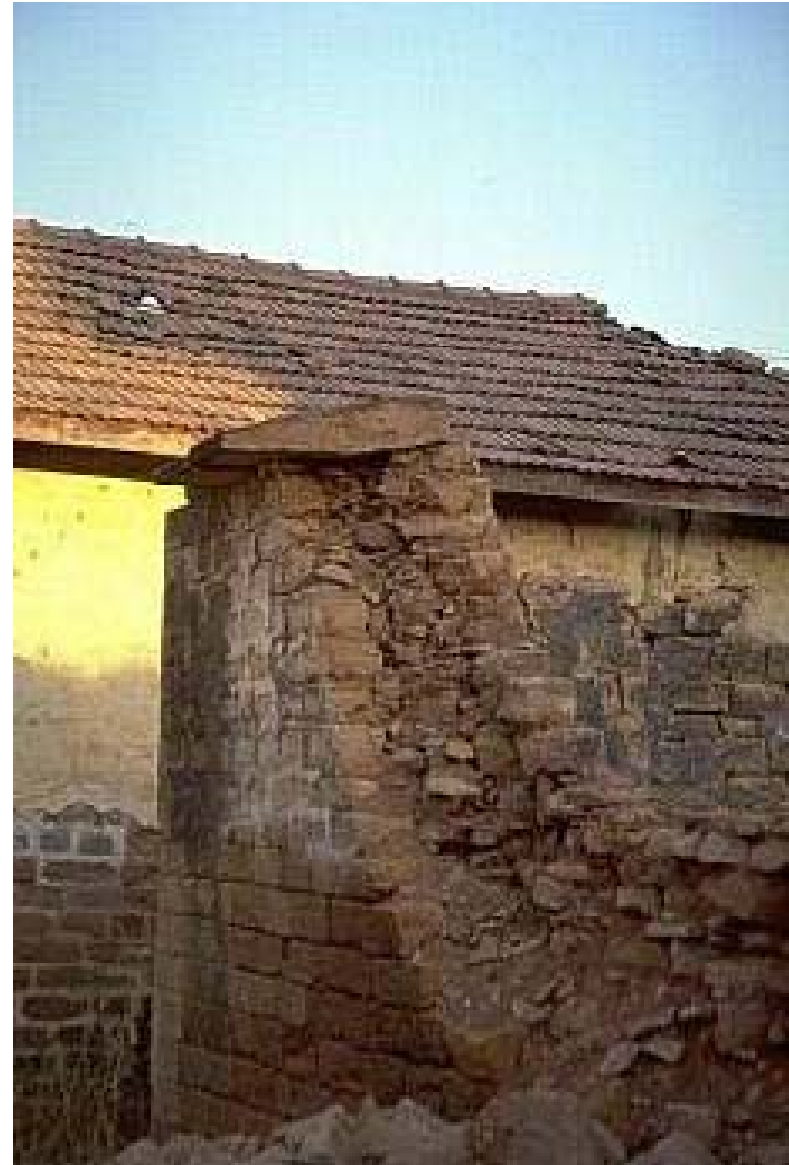
Masonry

- Insufficient cohesion of the masonry walls due to weak mortar or the absence of mortar

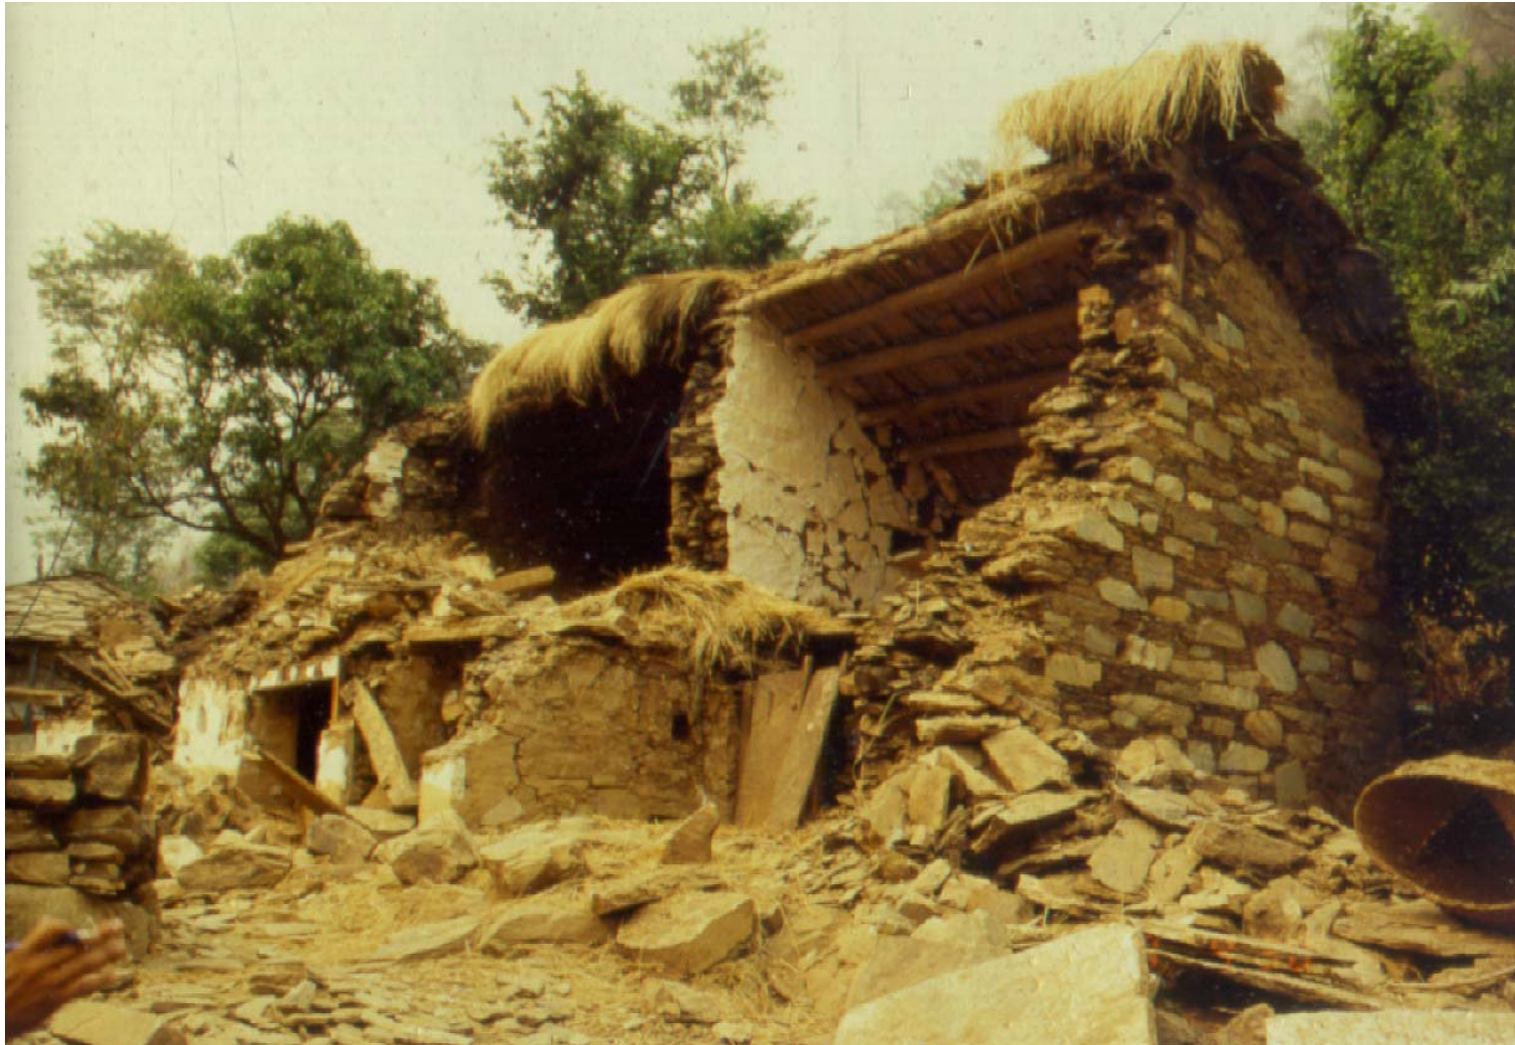
Stone masonry: behavior during an earthquake
