# IDENTIFICATION OF GEO-HAZARDS FOR THE REHABILITATION PLAN OF YALOVA TURKEY

## ABSTRACT

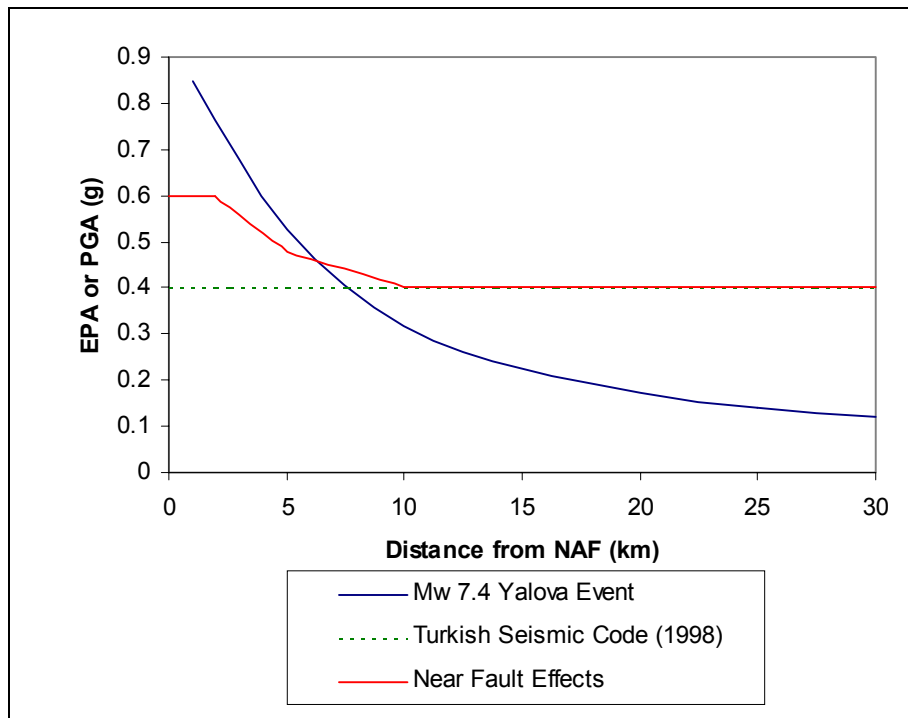
As part of this study, therefore, the ground shaking due to a 7.4M<sub>W</sub> earthquake on the Yalova segment of the North Anatolian Fault Zone has been used. The peak ground acceleration (PGA) is compared in Figure 2 with the Effective Ground Acceleration Coefficient (A<sub>0</sub>) given in the Turkish Seismic Code [2]. The value of A<sub>0</sub> for Yalova is 0.4g. Figure 2 shows that the value of bedrock PGA may be significantly greater than the currently specified EPA value within about 10km of the Yalova segment of the North Anatolian Fault Zone. Therefore, the seismic design forces for 1 to 3 storey structures may be increased by the amount indicated in Figure 2. It is also interesting to note in Figure 2 that the use of near fault factors given in the Uniform Building Code [9] would more closely represent the postulated bedrock PGA from the assumed 7.4M<sub>W</sub> earthquake. It was also estimated that the seismic design forces for taller, longer period structures could exceed the current specification up to about 15km from the Yalova segment of the North Anatolian Fault Zone.

Figure 2: Comparison of acceleration with distance from Yalova segment of North Anatolian Fault for the Turkish code and the postulated magnitude 7.4M<sub>W</sub> event

- Within about 10km of the Yalova segment of the North Anatolian Fault the ground motions are predicted to exceed those given in the Turkish Seismic Code [2] (see Figure 2). Use of Uniform Building Code [9] near fault factors could overcome this difference.
